# Property Inspection Report

## OPEN FRAME

[REDACTED]  
[REDACTED]  
**Sierra in West Ranch**

**Monday, December 08, 2014**

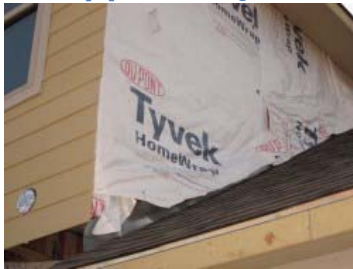
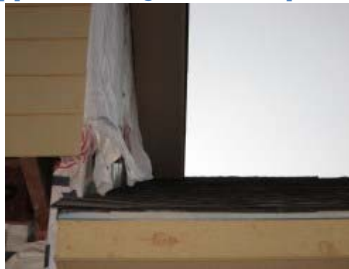
The flashing noted between the side walls and roof was hemmed (also known as "J") or "L" flashing. Flashing against a vertical sidewall should be the step-flashing type or method, a minimum of 4" high and a minimum of 4" wide and turned out at the end of the vertical sidewall in a manner that directs water away from the wall and onto the roof and/or gutter. **NOTE: While this flashing will become acceptable when the 2012 International Residential Code is adopted, and may be accepted by local code authorities, it does not meet the manufacturer's installation requirements.** [IRC 2006 §R905.2.8.4] [IRC 2009 §R905.2.8.3] [IRC 2012 §R905.2.8.3]

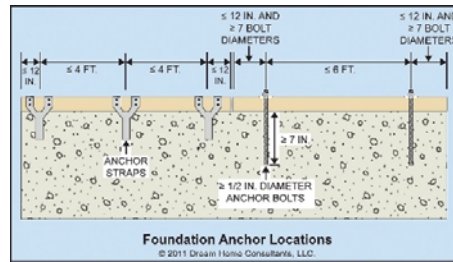
We were not able to determine whether the frame was properly anchored to the concrete slab; we did not have information on the length of the anchor bolts. Bolts shall be at least 1/2 inch (12.7 mm) in diameter and shall extend a minimum of 7 inches (178 mm) into concrete or grouted cells of concrete masonry units. There was at least four inches of bolt exposed therefore requiring a bolt at least 11 inches long. [2009 IRC §R403.1.6]

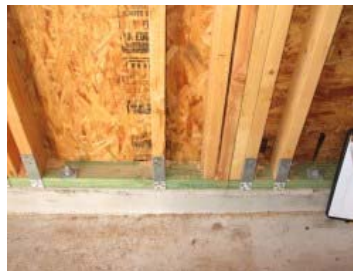
There was no anchor on one of the two sides at each of two splices in the sill plate on the outside wall of the garage. Wood sole plates at all exterior walls on monolithic slabs, wood sole plates of braced wall panels at building interiors on monolithic slabs and all wood sill plates shall be anchored to the foundation with anchor bolts spaced a maximum of 6 feet (1829 mm) on center. [2012 IRC §R403.1.6]

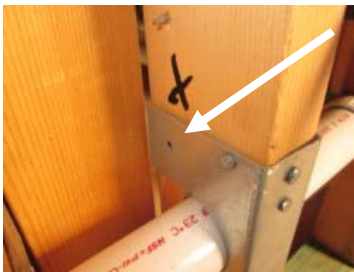
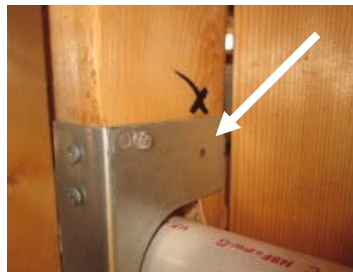
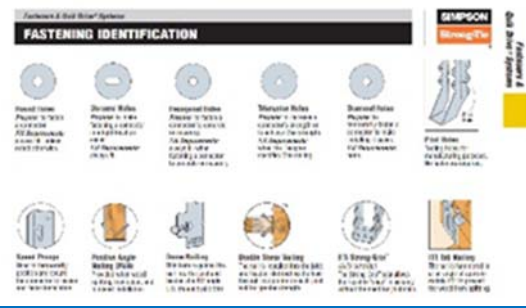
Nails were missing from two stud shoes over studs in the master bathroom at the inside-wall sink area. Simpson Strong-Tie, the manufacturer of this product, requires that all round holes be secured with fasteners.

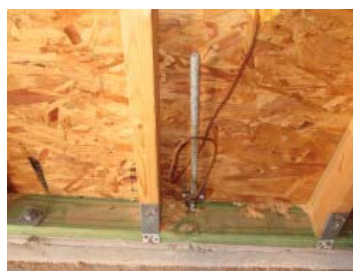
A concrete encased electrode (aka Ufer ground) was observed within the outside wall of the garage. This electrode is required when the concrete is in direct contact with the earth. Concrete installed with insulation, vapor barriers, films or similar items separating the concrete from the earth is not considered to be in "direct contact" with the earth. [2006 IRC §E3508.1.2] [2009 IRC §E3508.1.2] Note that while we are not able to positively determine whether such a vapor barrier is in place the International Residential Code requires that a 6-mil-thick polyethylene film be applied as a moisture barrier. [2006 IRC § R406.3.2] [2009 IRC § R406.3.2] *While the builder may have left a portion of the grade beam uncovered by a vapor barrier, we are not able to determine whether a) the exposed area provides enough contact, or b) whether damage may result in the event of high voltage discharge such as by lightning.*

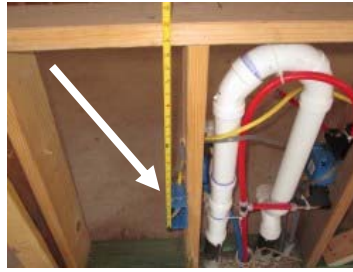
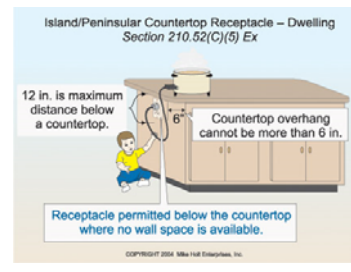
One or more receptacles on the back side of the peninsular counter at the kitchen sink was improperly placed. In kitchens and dining rooms (IRC 2006) or In kitchens, pantries, breakfast rooms, dining rooms and similar areas or dwelling units (IRC 2009 and IRC 2012), an outlet may be located no more than 12 inches below the countertop only when the countertop extends no more than 6" beyond its support base. [2006 IRC §E3801.4 through §E3801.4.5 Exception] [2009 IRC §E3901.4 through §E3901.4.5 Exception] [2012 IRC §E3901.4 through §E3901.4.5 Exception]

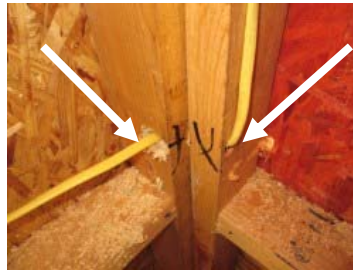
Nail-plates had not been applied on isolated studs where required: over 15 were observed and marked but this number does not reflect all deficiencies. Non-metallic cables run through bored holes in framing members shall not be closer than 1 1/4" from the edge of the framing member, or should be protected with a minimum 0.0625-inch steel plate or sleeve, a listed steel plate or other physical protection. Any others identified should be repaired at the same time. [2012 IRC Table §E3802.1]

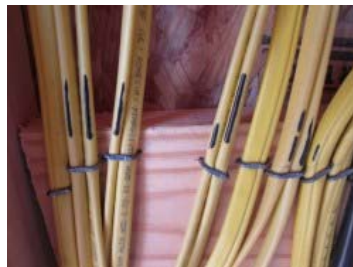
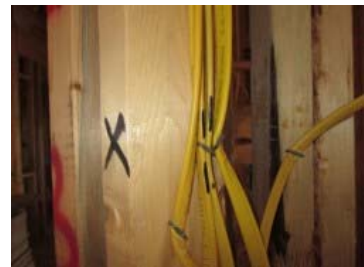
Electrical cables had been stapled on the edge in multiple locations, including, but not limited to;

- in the garage space, within 12 inches of the cabinet (10 or more)
- in the stud cavity to the right of the fireplace in the family room (4 or more)

Electrical cables had be Flat cables shall not be stapled on edge. To do so may damage the cable and may cause AFCIs to trip. Any others identified should be repaired at the same time. 2014 NEC 334.30

Cables marked with black marker

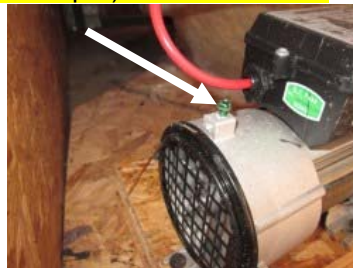
The hydro-massage therapy tub (aka "spa") was not bonded.

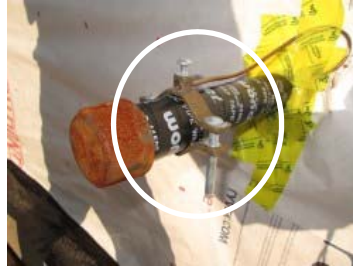
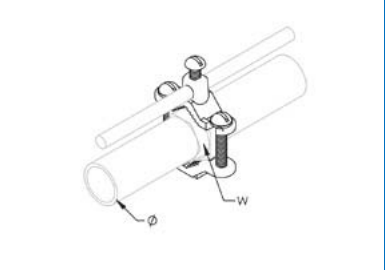
The gas pipe system's bonding clamp, located on the exterior where the meter will be installed, was placed over the pipe wrap and did not appear to create an effective bond.

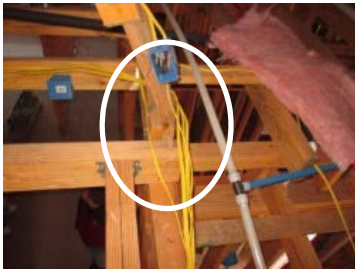
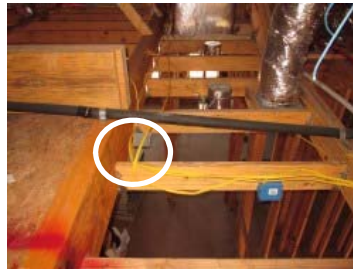
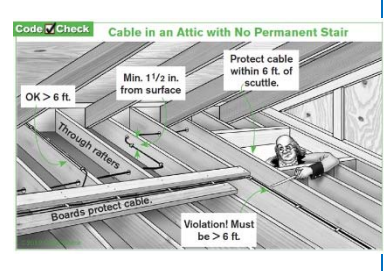
Cables were not properly protected in the attic space proximate to the opening framed for a pull-down stairway. Where runs across the top of floor joists, in attics and roof spaces that are provided with access, the cable shall be protected by substantial guard strips that are at least as high as the cable. [2009 IRC §E3802.2.1]

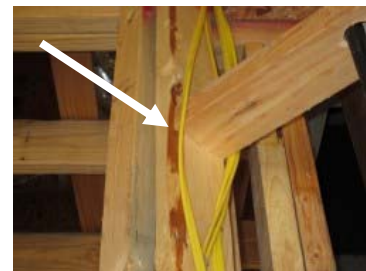
A cable was run outside of the stud cavity and must be repositioned before application of the insulation and drywall; left of fireplace as viewed from the family room.

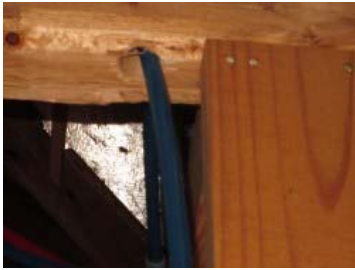
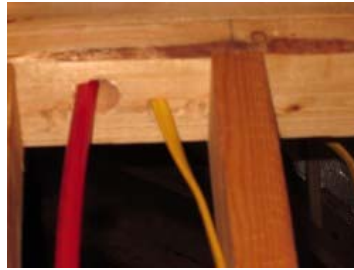
PEX water supply tubing was not protected where it passed through framing, including but not limited to:

1. the top plate in Bedroom #2 bath
2. studs in the master bedroom closet

Steel plates are required to protect water lines, other than galvanized and cast iron, where passing through bored holes that are less than 1 1/2 inch from the face of framing. [2009 IRC §P2603.2.1]

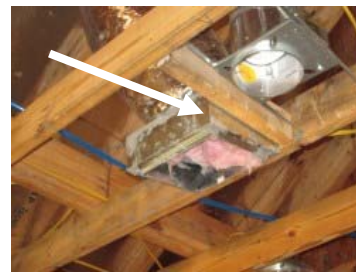
One supply air box above the kitchen space was not rigidly supported or secured to the ceiling framing.

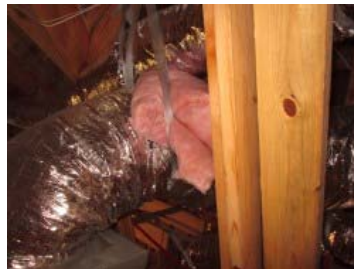
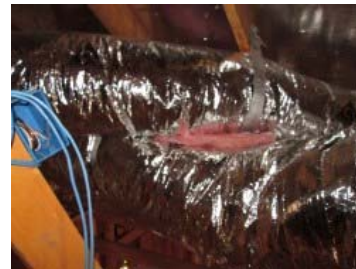
Portions of the duct were in contact with other runs. Direct contact, or even separation by insulation, may cause condensate to form leading to organic growth.

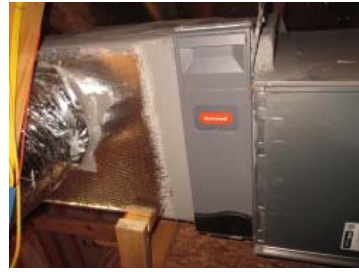
The cover of the media air filter, ahead of the first-floor equipment, had been partially sealed by mastic. This will prevent the home owner from easily accessing the filter for maintenance and replacement and attempts to remove the cover may cause damage.
