Property Inspection Report

Thursday, January 22, 2015

PROPERTY INSPECTION REPORT

Clay M. Collins, TREC # 7147

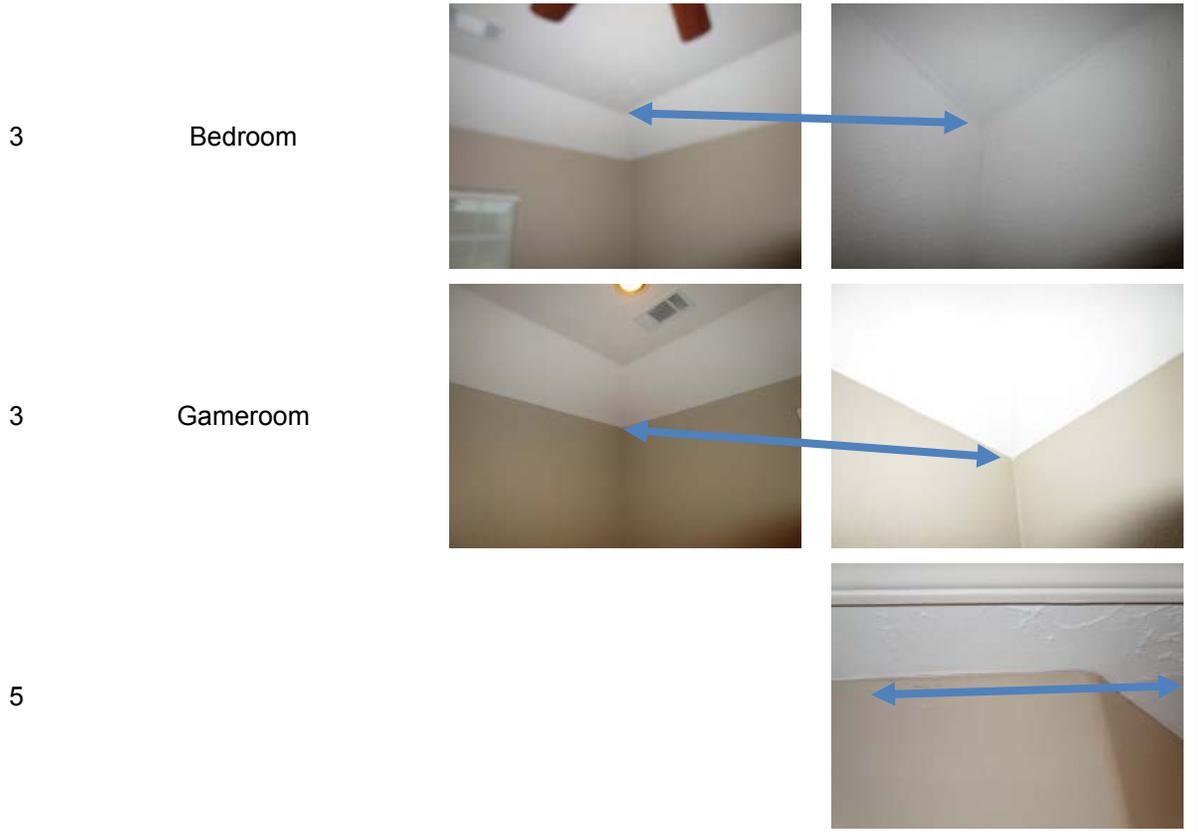
There was exposed reinforcing steel and/or tendons in the grade beam. This foundation was strengthened by post tensioned cables. The Post-Tensioning Institute (PTI) recommends that tendon ends be covered with at least 1" of grout. These should be sealed to prevent corrosion and potential failure of the cable. Do *not* use bagged cement or any product containing calcium chloride or other material deleterious to pre-stressing steel. See the illustration of the tendon "anchor" and "live" ends.

The Post Tensioning Institute (PTI) notes a requirement for a brass plate or stamp within the concrete floor of the garage space or metal tag on the water line noting: **Post Tension Slab: Do not cut or core.** Note that this requirement is for protection against repairs which may damage the cables and create additional damage to the foundation. These marking were not observed.

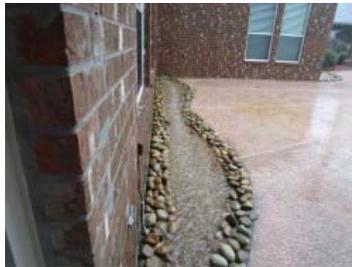
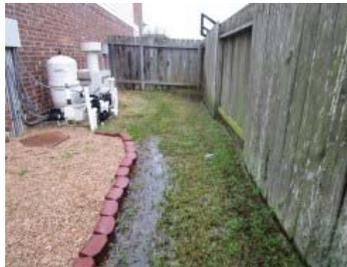
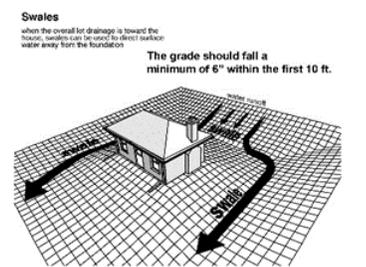
This lot did not appear to have the proper slope for drainage at all points along the foundation grade beam; this may lead to foundation distress. Lots should be graded to drain surface water away from the foundation walls. The grade should fall a minimum of 6" within the first 10'. Note that swales may have to be periodically re-cut to address the accumulation of yard clippings, mulch, leaves and other organic materials.

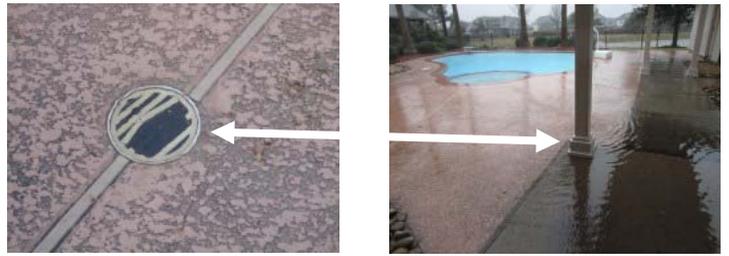
An underground drain was observed, but standing water indicated poor performance.

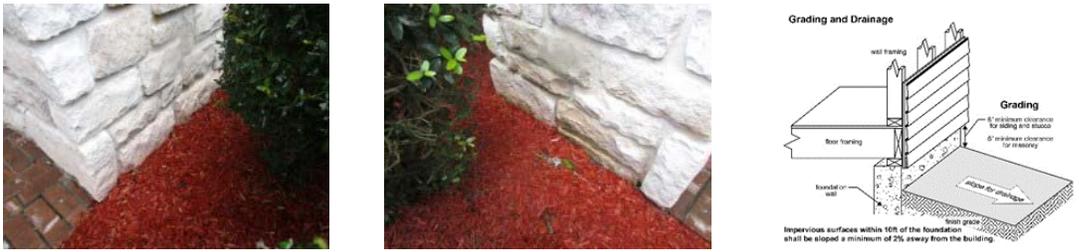
The soil levels were high against isolated areas of the foundation grade beam. When soil levels and vegetation are high against the face of the foundation it promotes water penetration, wood rot and insect infestation. Brick veneer wall cladding should have about 4" of clearance between the soil and the first course of bricks, and other materials should have 6" of clearance between other materials and the soil.

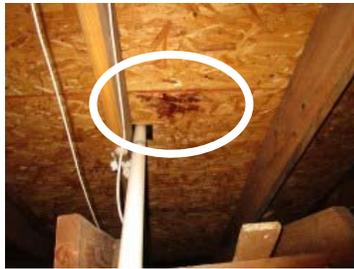
1

Water penetration was observed in the attic space.

1. In the south end attic space, just above the walk-through attic door (proximate to a repair noted above)

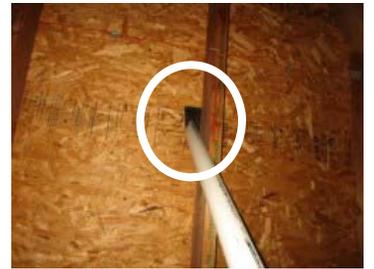
3

- In the attic space above the 2nd floor HVAC equipment proximate to a repair noted above
- At the drain waste vent at the top of the pull-down attic stairway

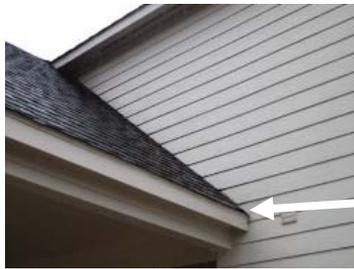
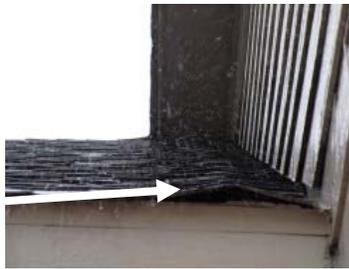
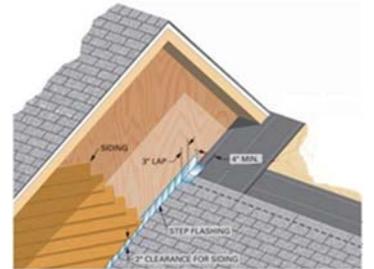
The flashing noted between the side walls and roof was hemmed (also known as "J" or "L" flashing). Flashing against a vertical sidewall should be the *step-flashing type or method*, a minimum of 4" high and a minimum of 4" wide and turned out at the end of the vertical sidewall in a manner that directs water away from the wall and onto the roof and/or gutter. **NOTE:** While this flashing may be acceptable by Authorities Having Jurisdiction and Code, it may not meet the manufacturer's installation requirements.

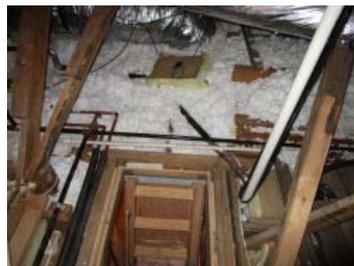
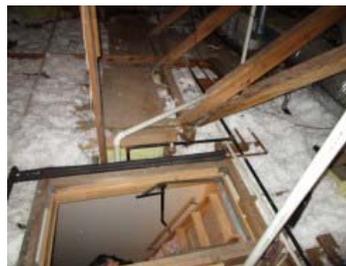
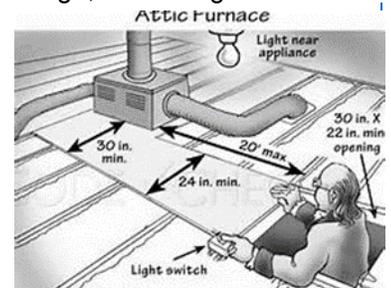
There was no landing platform at the top of the attic stairway. Decking should be installed at the top of the stair to minimize the risk of stepping onto, and falling through, the ceiling cover.

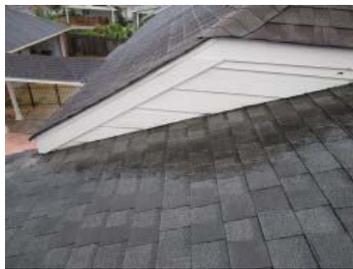
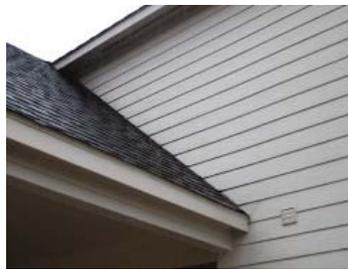
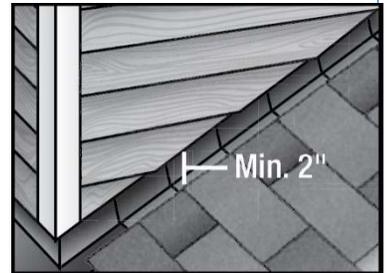
The vertical wall siding above the roof was in contact, or near contact, with the roof cover. The James Hardie Corporation's installation instructions state that a "minimum 2" clearance between James Hardie products and roofs, decks, paths, steps and driveways." This is intended to prevent wicking of water run-off which may degrade the material and shorten its useful life. [Manufacturer's Installation Instructions](#)

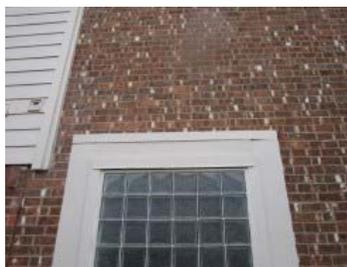
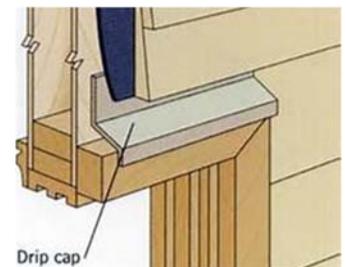
There was no flashing installed above projecting wood trim. Flashing shall extend to the surface of the exterior wall finish, continuously above all projecting wood trim.

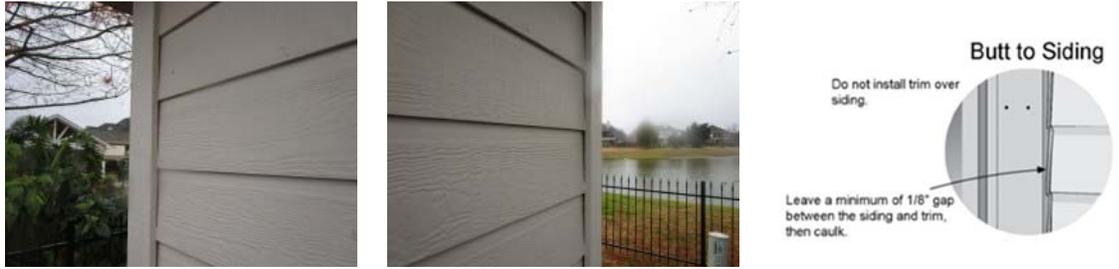
The fiber-cement siding was installed beneath the trim rather than butting to the trim. [Manufacturer's Installation Instructions](#)

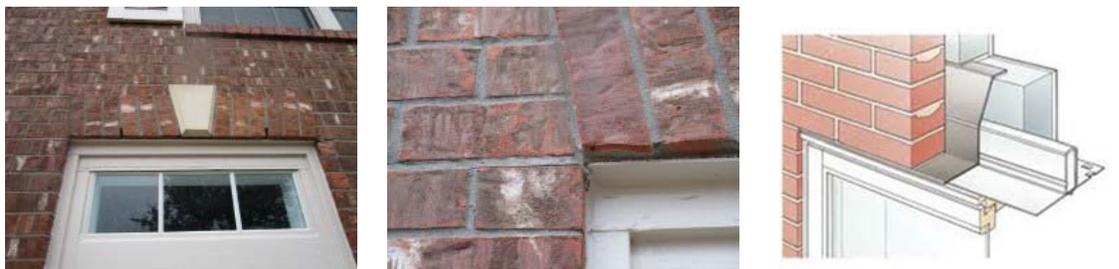
Flashing was either missing or improperly installed above cavities in the masonry veneer. Flashing above cavities in masonry walls should be *installed above* the steel lintel and should *extend through the wall out to the front edge* of the steel lintel. Note that we were not able to evaluate the window or door wraps behind the masonry which may be intended to serve as flashing. While technically deficient we make no recommendation for repair.

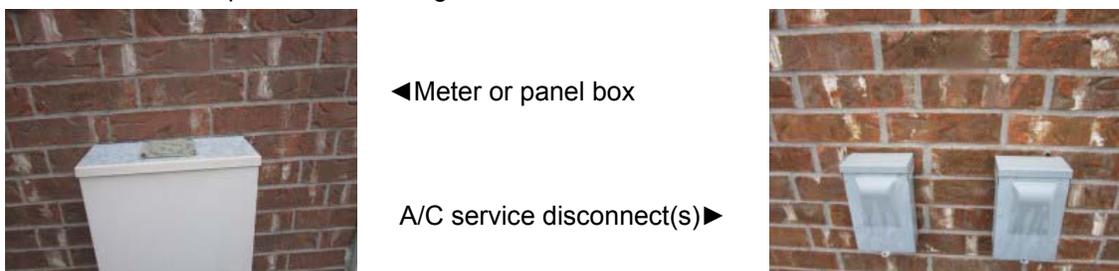
There was no flashing installed or sealant applied above either/or the electric service panel, meter box or A/C condenser's service disconnect. Such flashing is intended to prevent moisture from passing through the masonry veneer behind the service disconnect. We recommend applying an exterior grade, permanently flexible caulk to seal the top and sides, but *not the bottom*, to minimize the risk of moisture penetration through the wall cover.

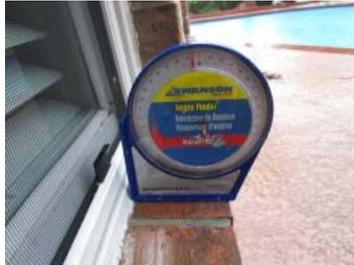
There was no flashing or weep holes observed beneath the masonry sill. While technically deficient, we make no recommendation for repair.

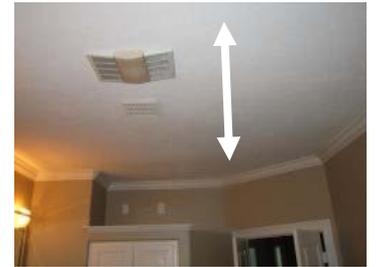
There was evidence of previous repair to the ceiling cover above the master bathroom. While we were not able to determine the cause of this damage, we noted that this area was immediately beneath a 2nd floor bathroom. There was no evidence of an ongoing issue. No staining was visible on the ceiling cover as observed from the very limited view within the attic space.

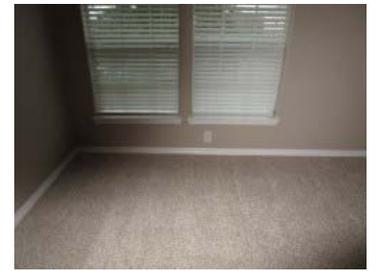
One or more 2nd floor windows were less than 24" from the floor. The lowest part of operable windows located more than 72" above the finished grade should be at least 24" above the finished floor of the room in which the window is located *by current standards*. Glazing between the floor and 24" should be fixed or have openings no larger than 4". We recommend caution with infants and children around these windows.

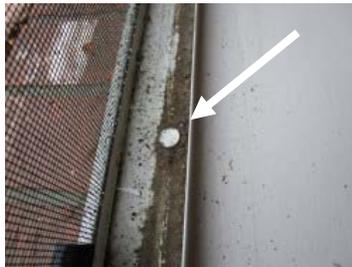
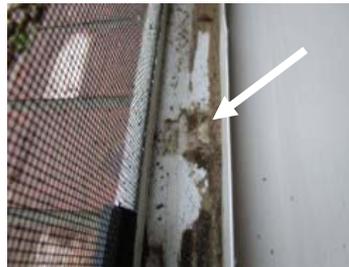
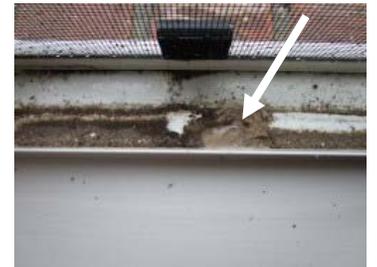
The window sills had been drilled for the installation of alarm contacts. Manufacturers of most window frames specifically prohibit drilling holes in the window sill for installation of alarm contacts. We were not able to determine whether there was any hidden latent damage caused by this condition. We recommend that each of the contacts be caulked as a preventative measure against moisture damage.

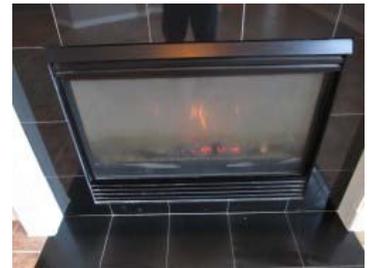
The glass hearth cover appeared scorched. This typically reflects a poor burn pattern and may be the result of poor placement of sand and lava rock.

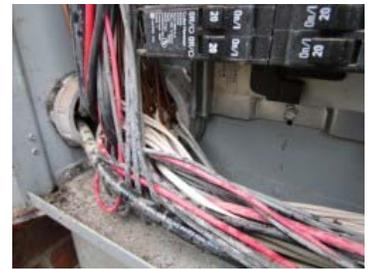
Circuit conductors were not grouped. Conductors of multiwire branch circuits (both grounded and ungrounded) must be grouped together with cable ties, or by some other means, at every place where splices or terminations are made. If the routing through openings makes this clear, cable ties are not required.

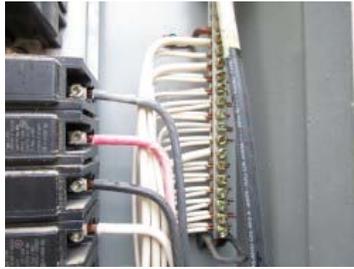
There were multiple conductors, specifically neutral conductors, improperly affixed beneath at least one lug. Each conductor (including neutral conductors) should be individually lugged.

◀ Multiple neutrals on one lug

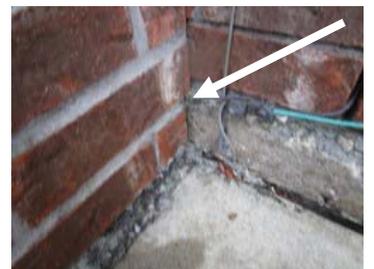
The rod and pipe electrodes shall be installed such that at least 8' of length is in contact with the soil. The upper end of the electrodes shall be flush with or below ground except where the aboveground end and the grounding electrode conductor attachment are protected against physical damage.

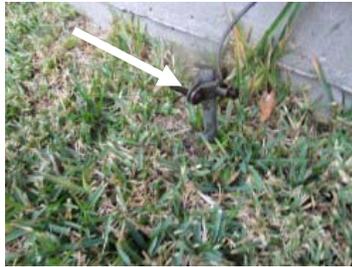
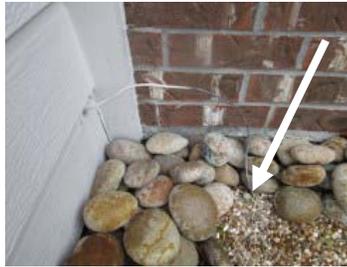
The clamps at the ground rods did not appear to be proper (i.e. rated for ground rods). The clamp observed was listed as a pipe clamp for metal water or gas lines. We recommend the use of a brass "acorn" style clamp, U.L. listed and approved for direct burial, on the ground rod for a more secure, longer lasting connection.

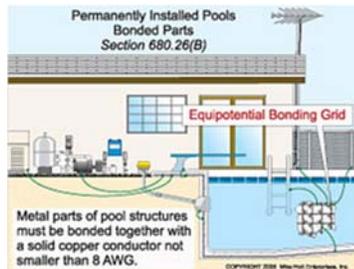
Bonding conductors were observed on each of the pool pumps, heating equipment and air blower, but we could not determine whether the conductor properly connected to the pool's bonding grid (buried system not visible). Metal parts of electrical equipment associated with pool, spa and hot tub water circulating systems, including pump motors, should be bonded with a minimum of solid 8 AWG conductor.

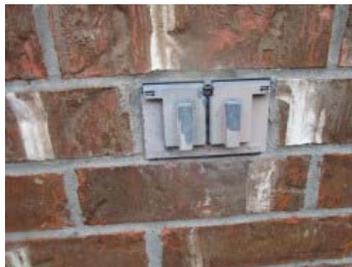
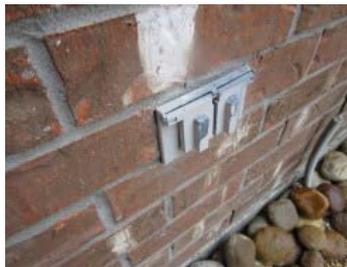
There was at least one improper outlet cover installed out-of-doors. In wet locations, outlets should be equipped to prevent moisture from entering or accumulating within the box. Where installed in a wet location, receptacles should, by today's standards, have an enclosure that is weatherproof whether or not the attachment plug cap is inserted.

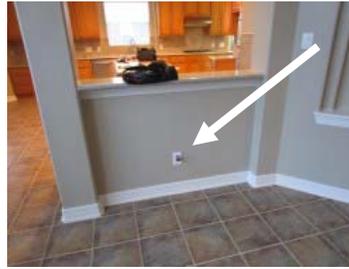
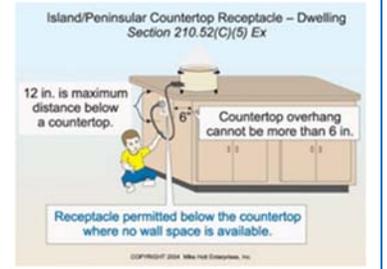
An outlet, on the back side of the peninsular counter at the kitchen sink, was improperly installed. An outlet may be located no more than 12 inches below the countertop only when the countertop extends no more than 6" beyond its support base. The intent is that the receptacle will be available for small appliances used on the countertop while minimizing the risk of snagging and pulling the appliance off the countertop. This outlet was 28" below a 4" overhang.

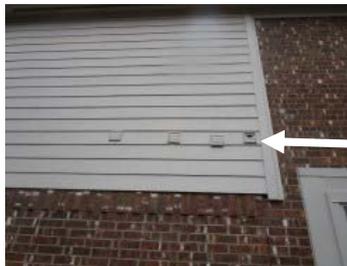
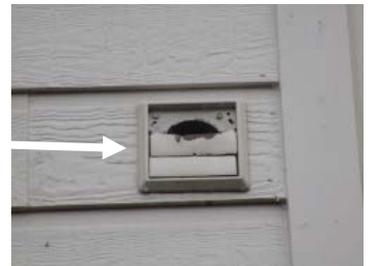
One louver was missing from one vent cover on the left side.

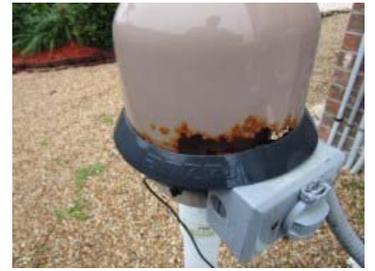
The air-blower was functional, but the cover had corrosion damage which may have reduced the appliance's useful life.

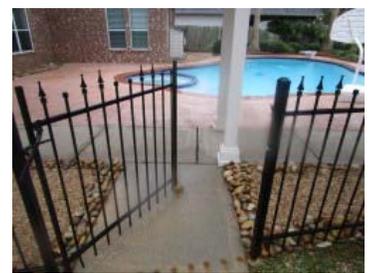
The pool barrier(s) were not proper for personal safety and protection against liability claims. There are specific requirements regarding locks and access to exterior areas providing direct access to swimming pools. Complete information on barrier and door requirements when there is a pool is located in the Addendum.
