Property Inspection Report

OPEN FRAME

Amos Benjamin Charles
5115 Marble Acres Ct.
Houston, TX 77059
Reserve at Clear Lake

August 01, 2017

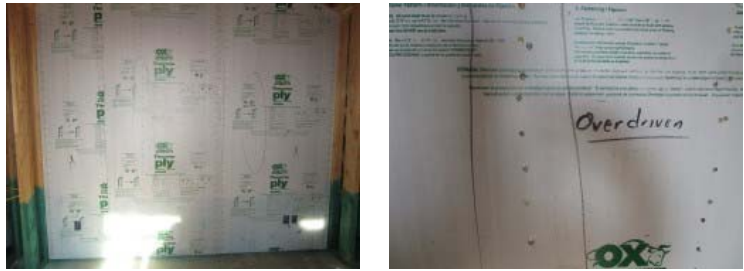
Nails were overdriven at interior shearwalls. The nail pattern appeared proper on the edges and in the field of the sheathing, but overdriven nails will reduce the effectiveness of fastening. We recommend that the design engineer approve the installation or stipulate repairs.

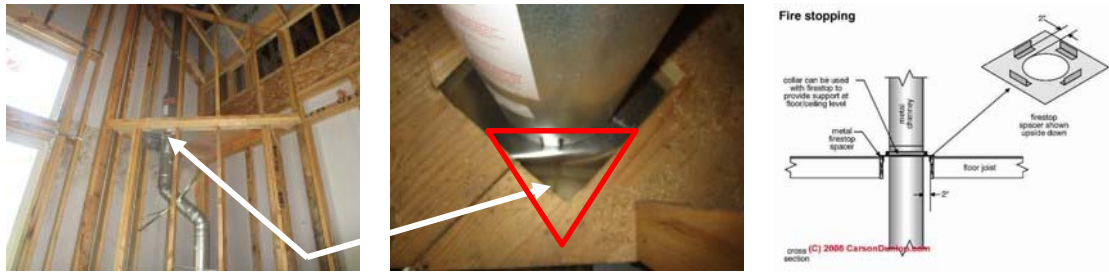
The metal firestop collar installed in the fireplace chimney chase was not installed well and will not protect against fire drafting. We recommend that this be repaired for fire safety. **REVISED:** The area which requires repair is marked on the photograph below in Red. This gap cannot be repaired using caulk or expanding foam; a hand can be placed through the gap.

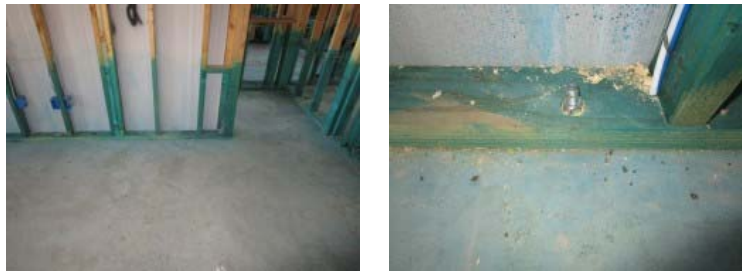
Notice: Standard round washers installed at slab anchor bolts had been driven beneath the face of the wood, potentially reducing the strength of the anchor. We recommend that the design engineer approve the type of washer and installation or stipulate repairs.

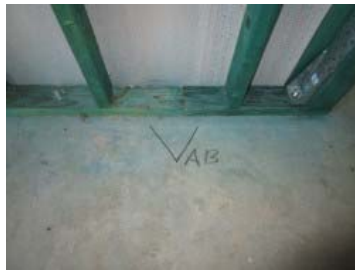
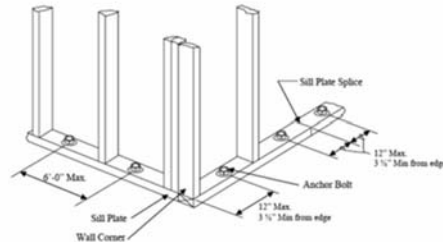
Notice: Anchors were not installed within 12 inches of a splice in the wall between the great room and master bedroom. While this would not typically be an issue at an inside wall, this wall appeared to be designed and installed as a shear wall. We recommend that the design engineer approve the installation or stipulate repairs.

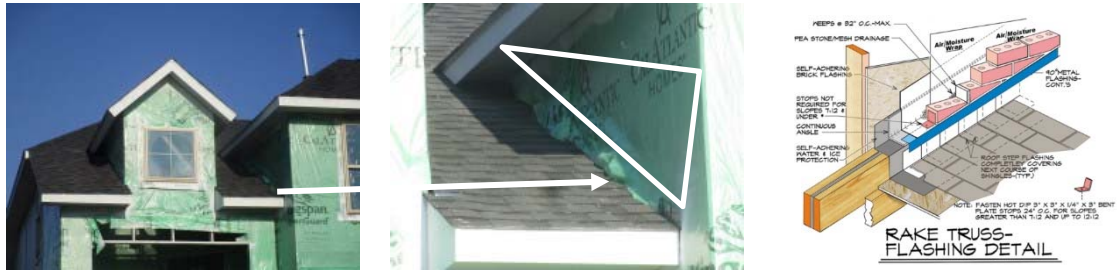
Notice: There did not appear to be a triple rafter at the rake truss at the sidewall above the garage space. This extra support is required to support the weight of masonry veneer. If this area is to be clad with masonry, we recommend that the design engineer approve the installation or stipulate repairs.

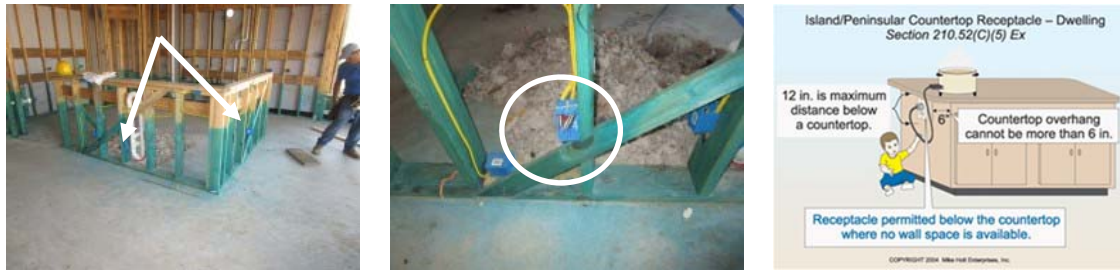
One or more receptacles on the back side of the peninsular counter at the kitchen sink was improperly placed. In kitchens and dining rooms (IRC 2006) or In kitchens, pantries, breakfast rooms, dining rooms and similar areas or dwelling units (IRC 2009 and IRC 2012), an outlet may be located no more than 12 inches below the countertop only when the countertop extends no more than 6" beyond its support base. While technically deficient this is common and may be acceptable to the Authorities Having Jurisdiction (AHJ). [2006 IRC §E3801.4 through §E3801.4.5 Exception] [2009 IRC §E3901.4 through §E3901.4.5 Exception] [2012 IRC §E3901.4 through §E3901.4.5 Exception]

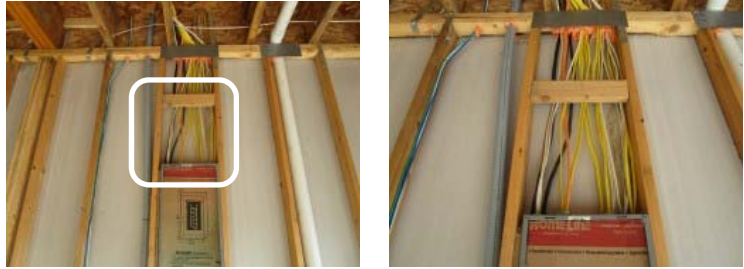
Branch circuit cables were not secured within 12 inches of the panel box. Nonmetallic sheathed cable shall be supported and secured by staples, cable ties, straps, hangers or similar fittings designed and installed so as not to damage the cable, at intervals not exceeding 4 1/2 feet and within 12 inches of every outlet box, junction box, cabinet or fitting. We recommend that this be repaired for fire safety. **REVISED:** Amendments to the IRC adopted by the City of Houston in Ordinance 2015-1108 effective 02/01/2016 included "DELETE CHAPTERS 34 – 43 IN THEIR

ENTIRETY". The City of Houston has adopted the 2014 NEC in lieu of the Electrical chapters of the IRC. This reported item is, therefore, not dependent on the IRC. [2014 NEC 334.30](#)
