# Property Inspection Report

**Amos Benjamin Charles  
5411 Marble Acres Ct.  
Houston, TX 77059-1413  
Reserve at Clear Lake**

**October 01, 2017**

**Concerning:** 5115 Marble Acres Ct., Houston, TX 77059  
(Address or Other Identification of Inspected Property)

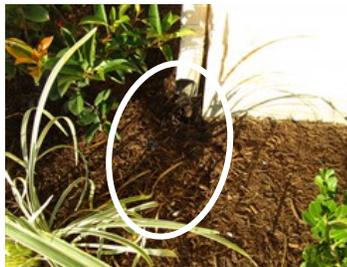
One downspout in the gutter system directed water less than 5ft away from the slab (the splash block was missing in the front garden bed). This may cause erosion at the foundation and allow undesirable movement.

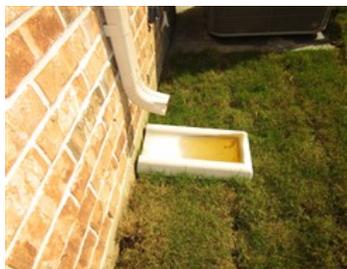
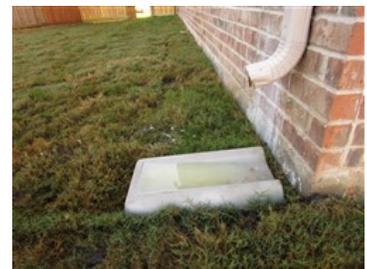
*Maintenance:* Two downspouts ended about 1 foot above ground. Because of the angle of the downspout elbow, run-off may over shoot the splash block and erode the ground. We recommend lowering the discharge.

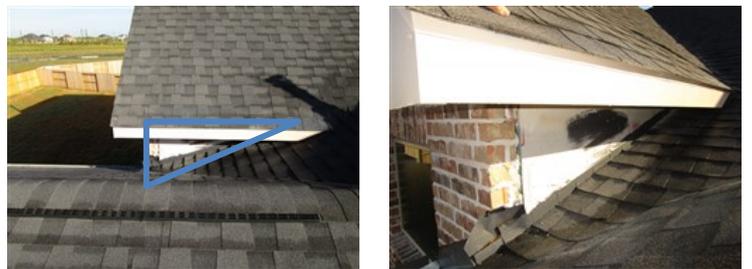
Isolated wall cladding was missing above the back patio cover. This must be repaired.

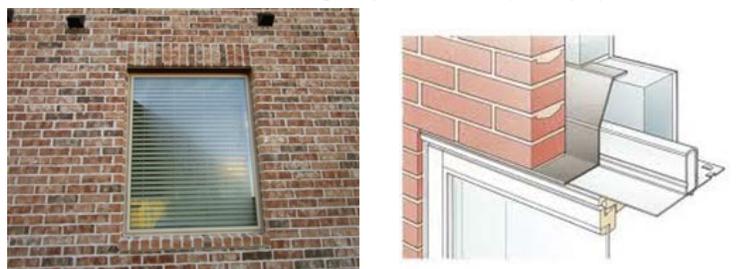
Flashing was either missing or improperly installed above cavities in the masonry veneer. Flashing above cavities in masonry walls should be installed above the steel lintel and should extend through the wall out to the front edge of the steel lintel. Note that we were not able to evaluate the window or door wraps behind the masonry which may be intended to serve as flashing. While technically deficient we make no recommendation for repair. [2009 IRC §R703.8.1]

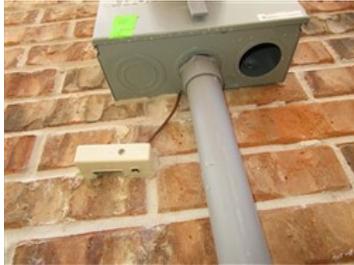
◀ Meter or panel box

The bottom edges of the service meter box and the service disconnect boxes had been caulked. These boxes should not be sealed at the *bottom edge*. The caulk on the top and sides is intended to prevent water from passing behind the box and reentering the building envelope, but the bottom edge should be open to allow any moisture that does pass through, to exit. We recommend that the bottom seal be cut and removed.

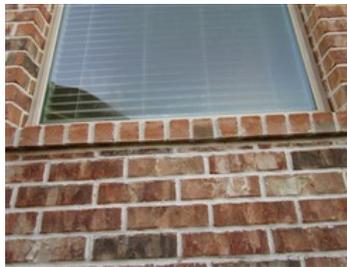
No flashing or weep holes were observed beneath the brick rowlock-type sills beneath the windows set into masonry walls. While technically deficient, there was no evidence of moisture penetration at the time of this inspection and we make no recommendation for repair. [Brick Institute of America – Technical Note 36](#)

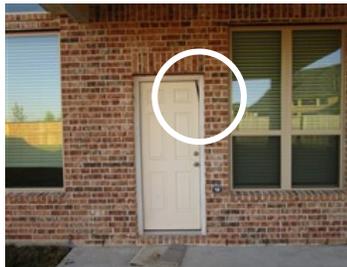
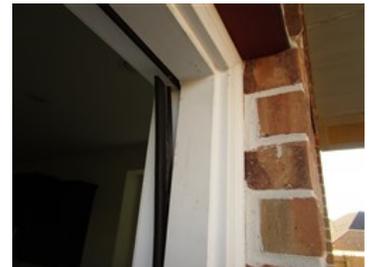
The weather stripping at the back door was damaged, or improperly installed. We recommend that this be repaired.

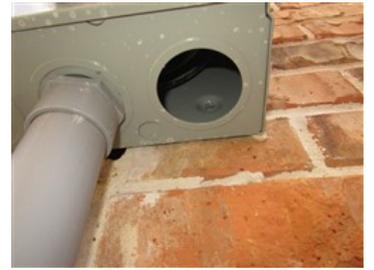
**A knockout was missing from the bottom of the meter can.** We recommend that this be repaired for safety.

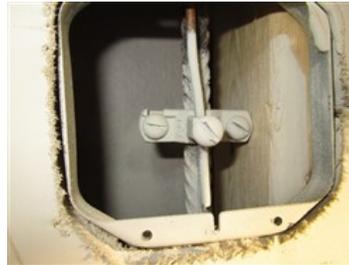
**A concrete encased electrode was installed in a slab not in full contact with the earth.** "Metallic components shall be encased by at least 50 mm (2 inches) of concrete and shall be located horizontally within that portion of a concrete foundation or footing that is in direct contact with the earth or within vertical foundations or structural components that are in direct contact with the earth. *NEC Informational Note: Concrete installed with insulation, vapor barriers, films or similar items separating the concrete from the earth is not considered to be in "direct contact" with the earth.*" While the builder may have left a portion of the grade beam uncovered by a vapor barrier, we are not able to determine whether a) the

exposed area provides enough contact, or b) whether damage may result in the event of high voltage discharge such as by lightening. The limited earth contact may not provide resistance-to-ground of less than 25 ohms. We recommend that resistance to ground be measured and if more than 25 ohms, then a second ground rod be installed [2014 NEC 250.52\(A\)\(3\)](#)

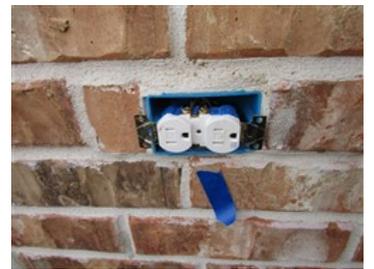
A receptacle cover was missing at the A/C condensing equipment.

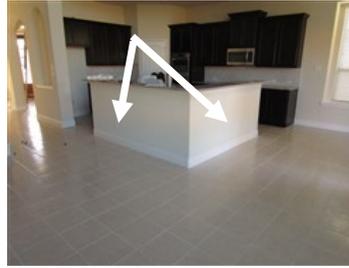
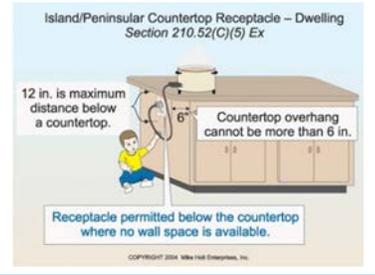
The HVAC equipment service switch in the attic space was upside down. While not technically deficient, it would be expected to make it awkward to determine whether the switch was on or off. We recommend that the switch be turned over for convenience.

One or more receptacles on the back side of the peninsular counter at the kitchen sink was improperly placed. *In kitchens and dining rooms* (IRC 2006) or *In kitchens, pantries, breakfast rooms, dining rooms and similar areas or dwelling units* (IRC 2009 and IRC 2012), an outlet may be located no more than 12 inches below the countertop only when the countertop extends no more than 6” beyond its support base. [\[2009 IRC §E3901.4 through §E3901.4.5 Exception\]](#) [\[2012 IRC §E3901.4 through §E3901.4.5 Exception\]](#)
