Property Inspection Report

COMMERCIAL INSPECTION

John Smith
1235 American Dr.
Pale Horse, TX 77555-1234

December 01, 2017

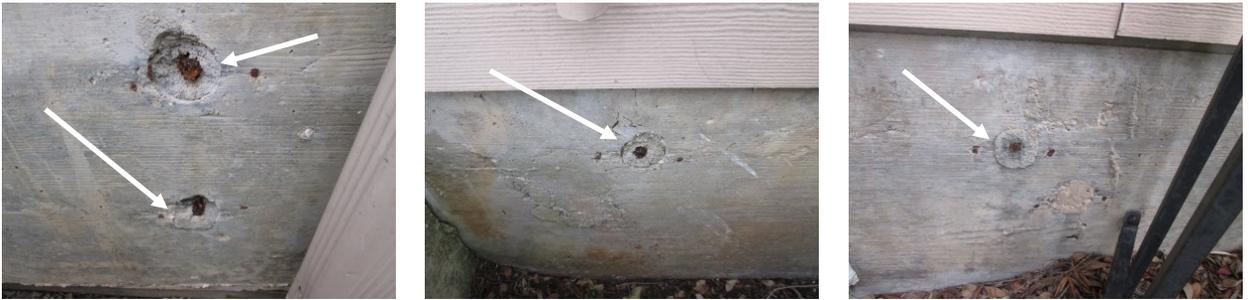
There were exposed un-bonded, post-tensioned cables around the perimeter of the slab. Exposure of these can facilitate corrosion of the steel and may, over time, cause failure of the cable or anchorage. This should be expected to be exacerbated by the proximity of this property to saline waters. We recommend that these cables be treated against corrosion and covered to preserve their useful life.

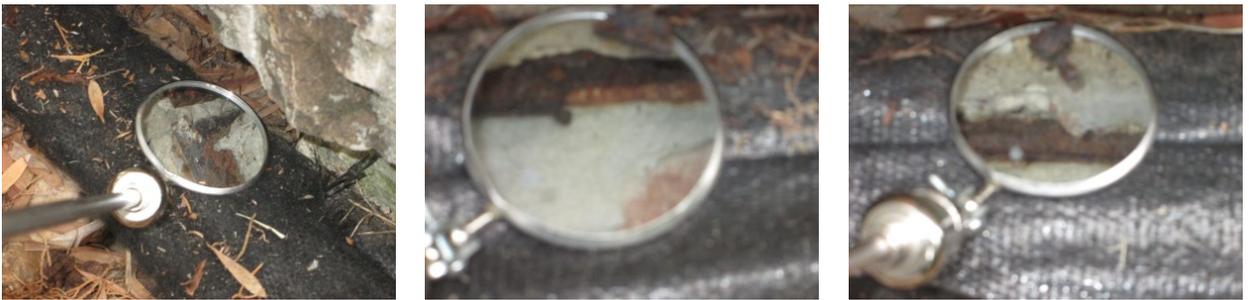
The masonry on the Southwest side was installed on steel lintels, some of which had significant measures of corrosion. The lintels were no more than two (2) inches above the ground along the garden bed, which served to promote the corrosion. These were not accessible for casual observation and appeared, with exception, to have been ignored since construction. While the walls were generally intact, this may fail over time without treatment and maintenance.

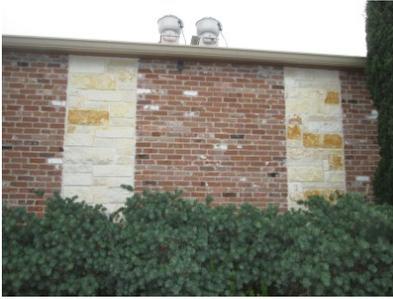
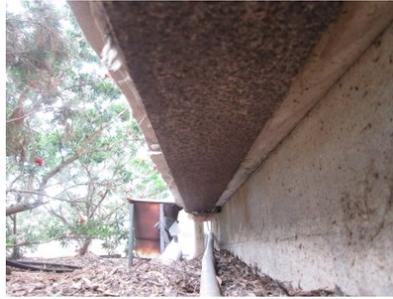
Older - Beneath brick

Exception: There were lintels that were newer than most. There were adhered stone insets within the brick on the Southwest side that appeared to reflect previous remodeling. These lintels were primed and in relatively good shape. We recommend maintenance to preserve the material's useful life.

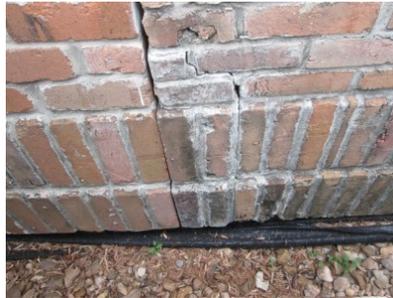
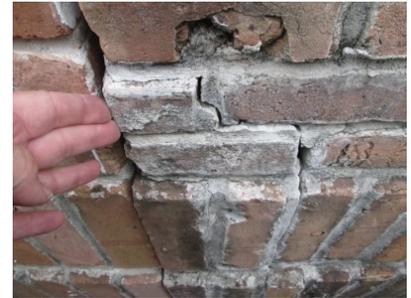
Brick was not secured at an isolated location on the Southwest side the control joint within the masonry veneer. Corrosion of the steel lintels may have contributed to this condition. We recommend that this be repaired to minimize the risk of exacerbating the damage and affecting proximate materials.

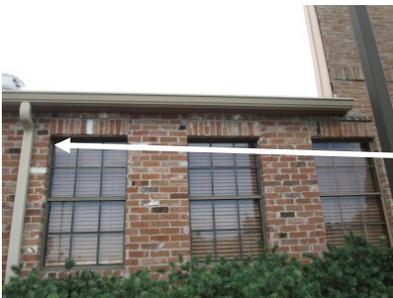
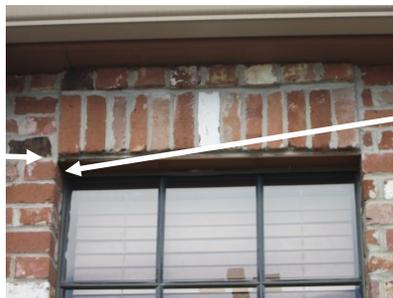
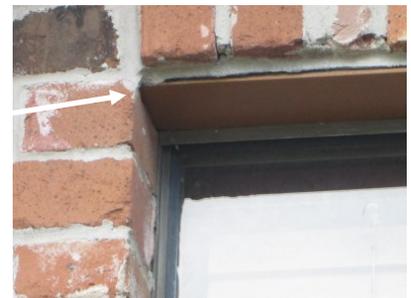
There was no flashing visible above the steel lintels. Flashing should extend out to the front of the wall. Note that this does not preclude the presence of flashing, just that it was not visible. While no repair is recommended, we recommend maintenance to preserve the material's useful life.

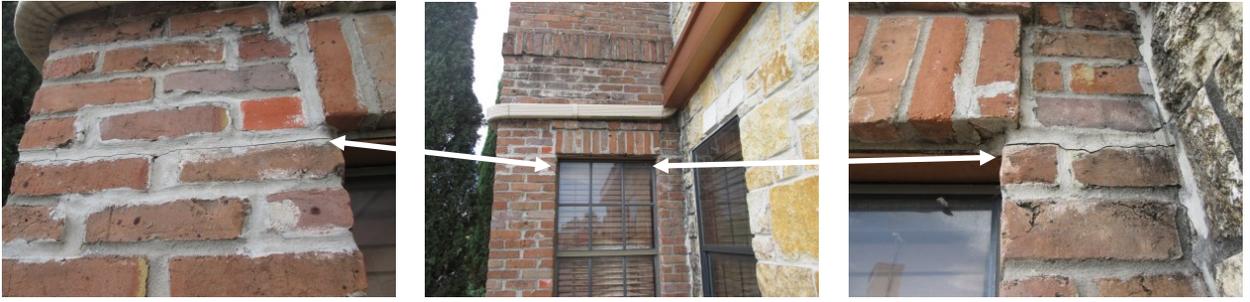
Masonry had been tuck-pointed at the south corner on either side of the window pictured below. The cracks were generally along the width of the steel lintel. It is not uncommon for such movement in these areas; the lintel is used to support the overlying brick and transfer the load to the slab. The area may be tuck-pointed again for cosmetics and otherwise, should be observed and maintained as necessary.

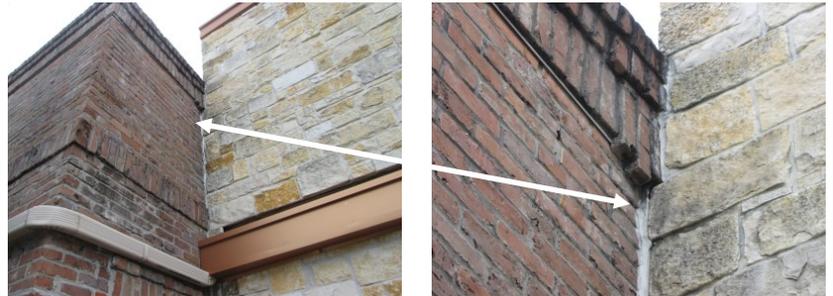
Mortar cracks in the vertical joint between the masonry wall and adhered stone façade appeared to be due to movement in the wood structure supporting the façade. See I.(g) below.

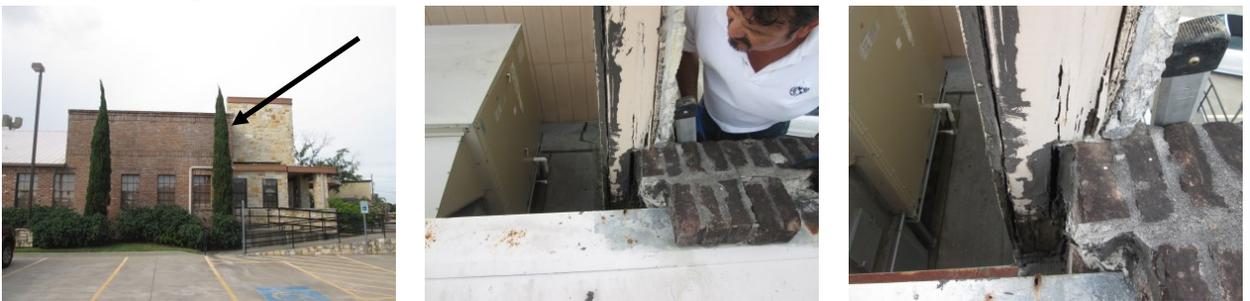
Damaged and decayed wood, providing the structural support to the façade hiding the roof-mounted mechanical equipment was observed. While performing at the time of this inspection, further deterioration should be expected. We recommend that the damaged materials be treated, reinforced or replaced as necessary. Recognize that these materials will pose a safety hazard should they fall.

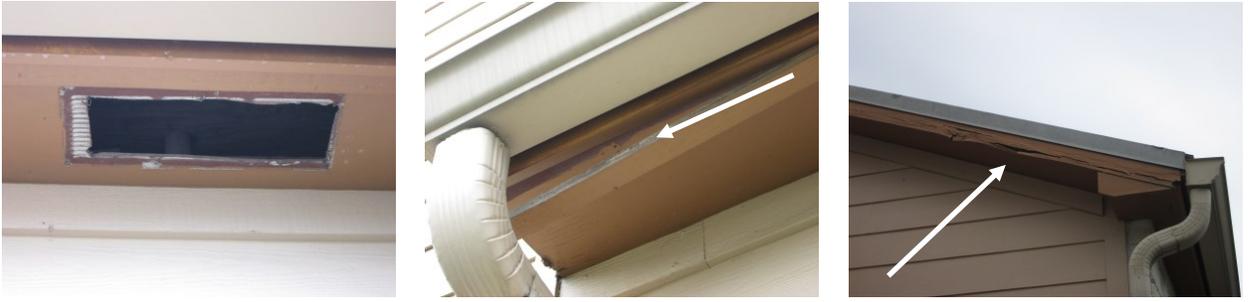
Isolated soffit vent covers were missing.

Fascia beneath the gutter system was decayed in isolated areas.

The bargeboard at the West corner was decayed.

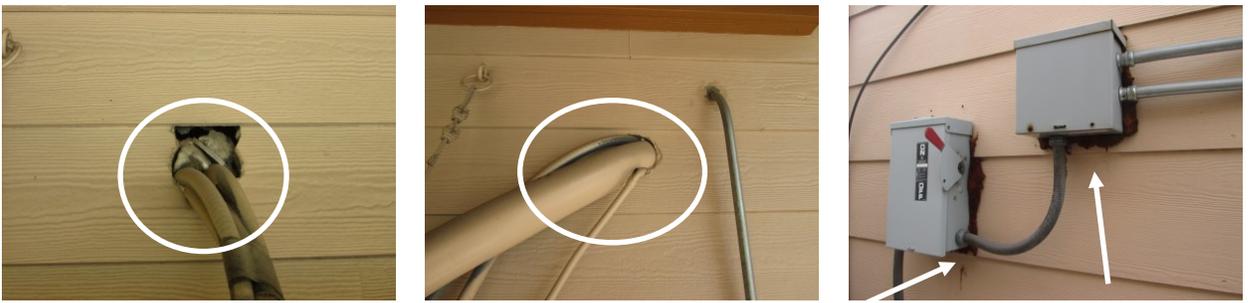
Flashing was not observed at some wall penetrations.

Sealant was observed on the underside at service panels and service disconnects. This may allow moisture to be trapped rather than drain.

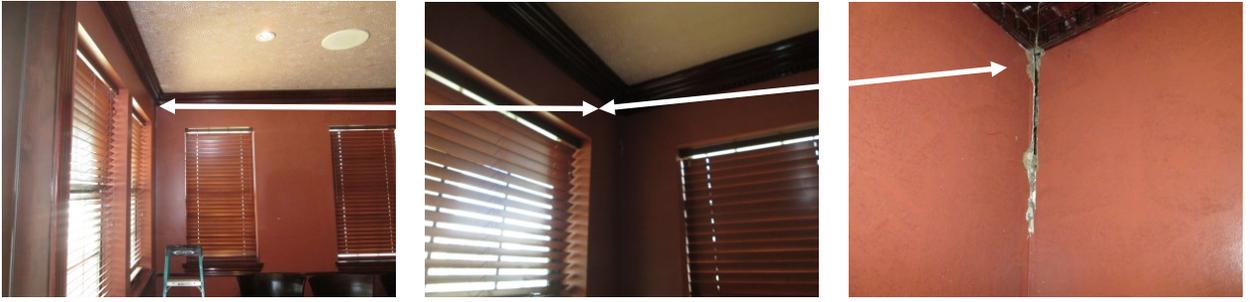
Damage to the drywall at the South corner of the waiting room was consistent with infestation of Wood Destroying Insects. While this was not a Wood Destroying Insects (WDI) inspection, the deterioration of the drywall and the dirt observed is typical of subterranean termite activity. We did observe drill holes in the concrete flatwork which would indicate previous treatment. We were not able to determine whether there was structural damage, or the extent of structural damage, without destructive investigation which might include the removal of drywall and ceiling cover. We recommend that information about history of infestation and treatment be provided, including information on warranties, requirements for re-inspection (typically annual inspections) and associated costs.

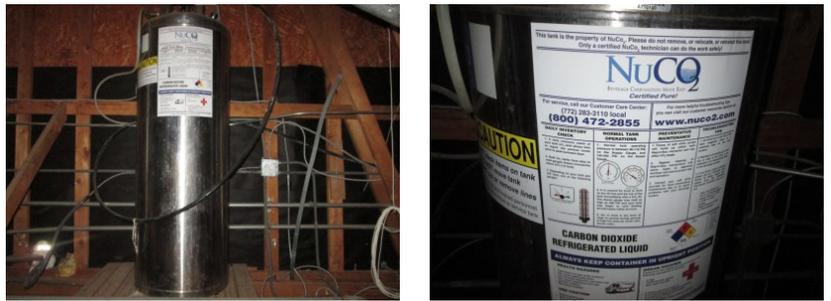
There was not safe, unobstructed access to equipment within the attic space, including the carbon dioxide tank.

There was no safety pan beneath the carbon dioxide tank. The use of this tank may generate condensate which can damage the ceiling cover. We recommend that a safety pan be installed.

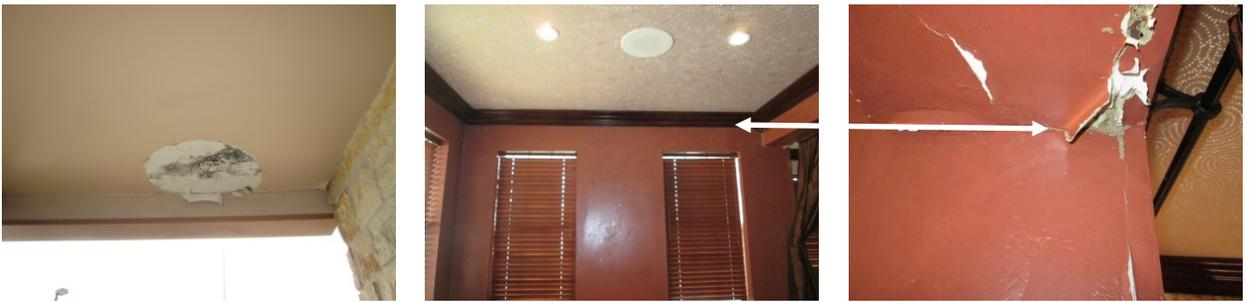
Evidence of moisture penetration and damage was observed beneath the front porch canopy and the drywall at the West corner waiting area. These areas were not wet at the time of this inspection as measured with a GE Surveymaster Protimeter (aka "moisture meter").

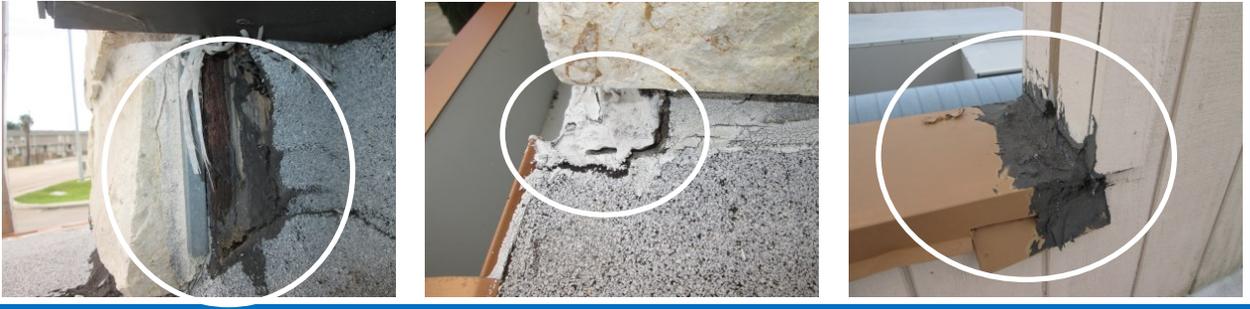
Evidence of repair to the roof cover was observed above the canopy. We were not able to view the space above the wall; there was no accessible attic space beneath the flat roof.

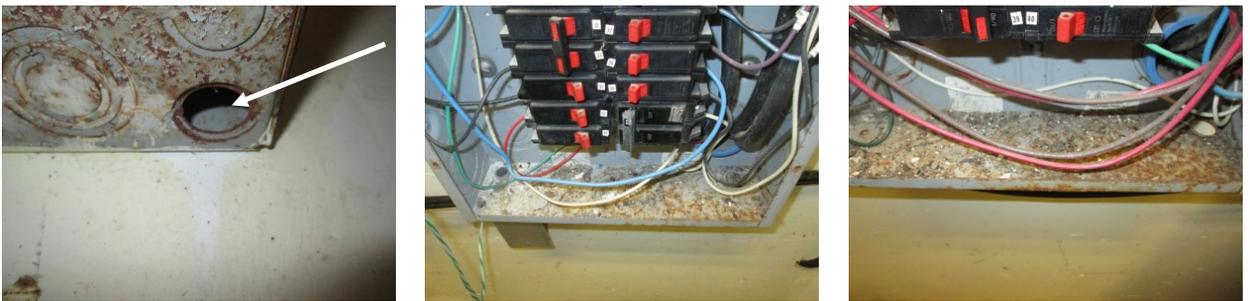
Undersized conductors were observed in two (2) or more locations:

- 10 AWG conductors were observed on each leg of a 240 volt, 50 amp overcurrent device. 10 AWG conductors are only rated for up to 30 amps.
- 12 AWG conductors were observed on each leg of a 240 volt, 30 amp overcurrent device. 12 AWG conductors are only rated for up to 20 amps.

Sheet metal screws were used to secure the panel covers. Only blunt-tip type screws should be used for fire and personal safety.

There were open knockouts in the bottom of the panel box. We recommend that this be closed or filled.

There was contamination in the bottom of the panel box. We recommend that this be cleaned, only as a part of regular service.

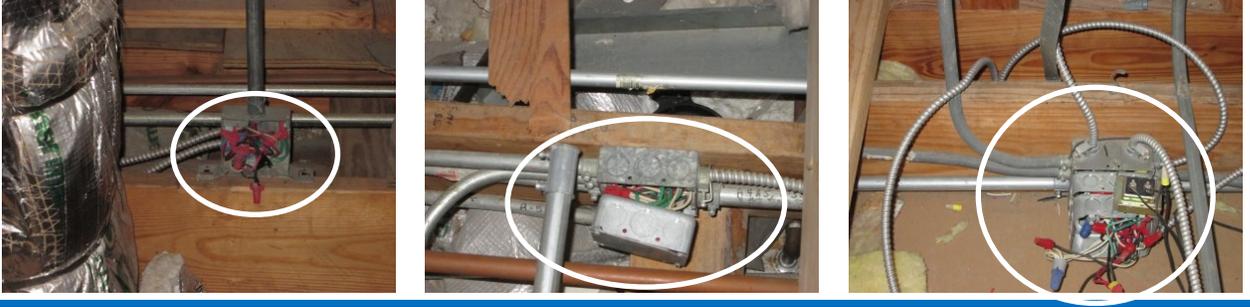
Cables and splice boxes were not covered or protected within the attic space.

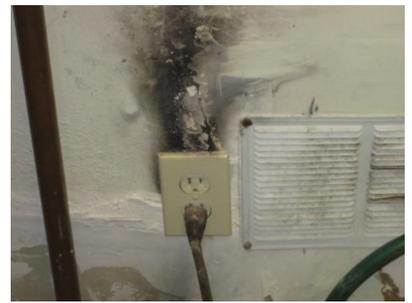
Evidence of scorching was observed at a receptacle within the utility closet. The receptacle appeared clean and damage free which would indicate repair. No recommendation.

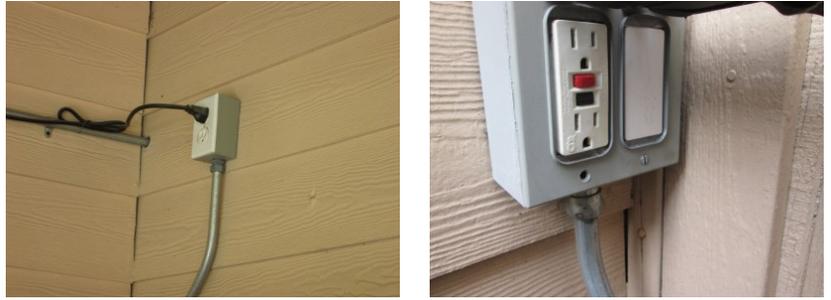
Some outdoor receptacles did not have proper covers and were not GFCI protected.

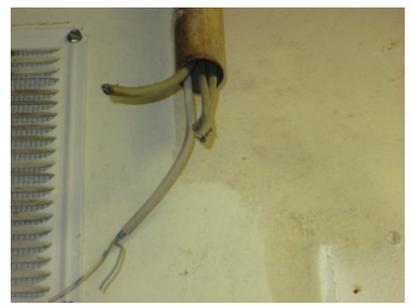
Cables within the utility closet were abandoned in place and did not terminate in listed splice boxes. There was no way to determine what conditions might occur that would energize these conductors. These should be properly terminated or pulled.

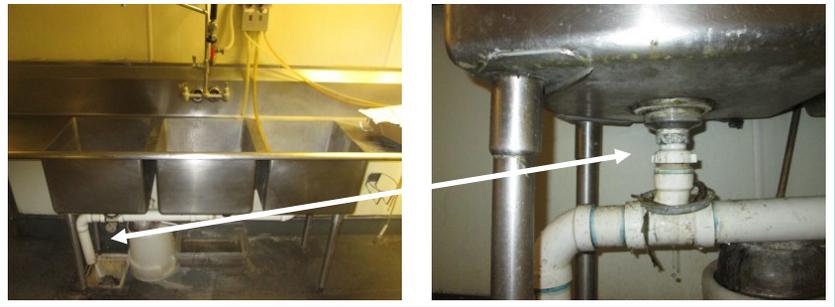
The left-hand and middle compartments leak at the drains (they appeared loose).

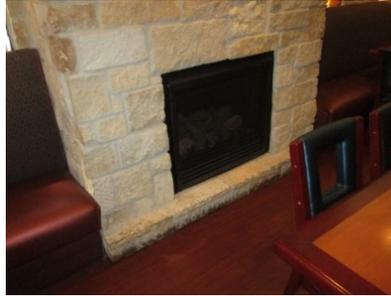
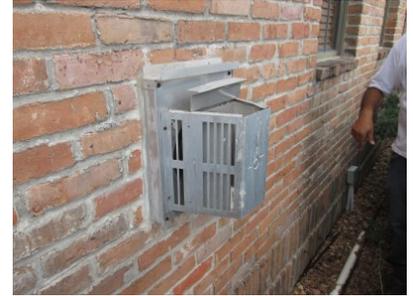
The fireplace was not inspected. This equipment was a closed compartment, direct vent type system and appeared to utilize a remote control to ignite the gas. No remote was located.

Direct vent fireplaces do not typically require outside combustion air; no vent was observed.

Closed fireboxes do not typically require a non-combustible hearth extension; none was observed. The manufacturer's instructions were not available for comparison against this installation.

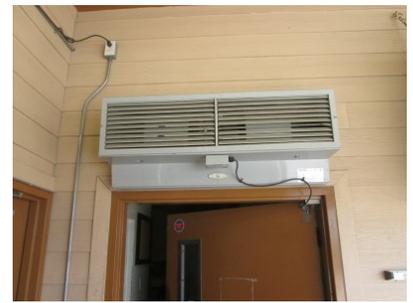
The door blower above the cargo bay was not functional. This appeared to be due to a bad door switch.

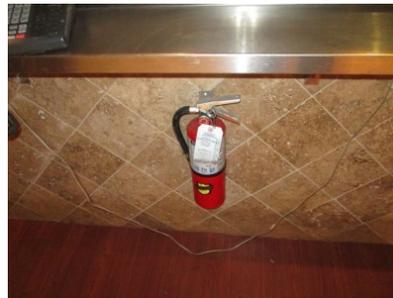
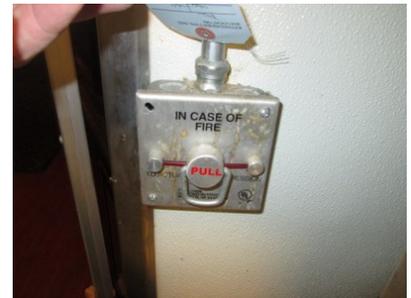
A single hand-held fire extinguisher was observed at the back-kitchen area. There was a fire suppression system installed over the kitchen cooking equipment. This equipment was not inspected.
