Property Inspection Report

PRE-POUR

Amos Benjamin Charles
5115 Marble Acres Ct.
Houston, TX 77059
Reserve at Clear Lake

July 01, 2017

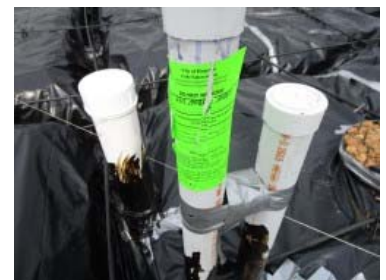
- The Authorities Having Jurisdiction (AHJ) Code Enforcement inspection approval "Plumbing Only" was posted on site.
- The compaction of fill materials, near surface soils and trench underground utility areas was not evaluated.

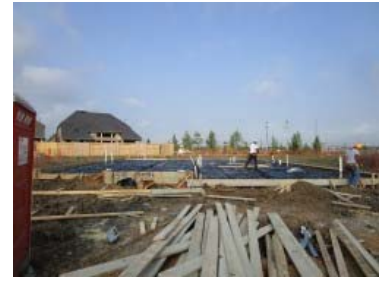
- Drainage for the slab-form had not been established; work had not progressed to a point that this would be expected to have been dug.

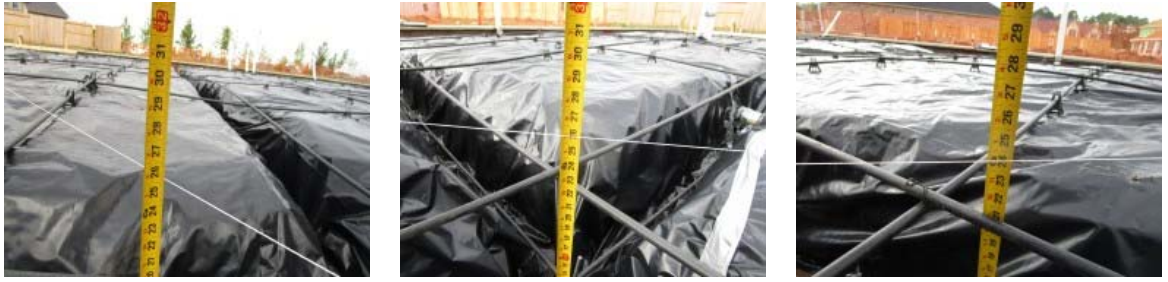
- The depth, width of the beams and thickness of the slab appeared adequate and generally met the values stipulated in Grade Beam Schedule.

Depth (24"): (A) 21, 26, 26, 26, 25
 (B) 27, 24, 24, 24, 25

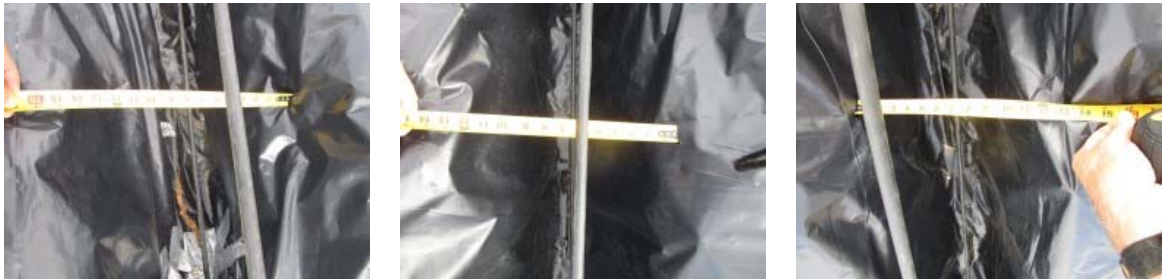
Width (10"): (A) 10, 11, 11, 12, 15
(B) 11, 10, 10, 10, 10

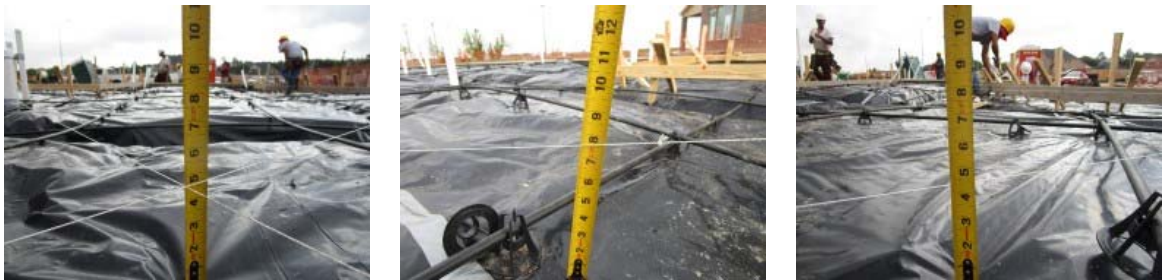
Thickness (4"): (A) 5, 5, 7, 6, 5, 5, 5, 5, 4
(B) 4, 4, 4, 4, 6, 6, 5, 5, 4

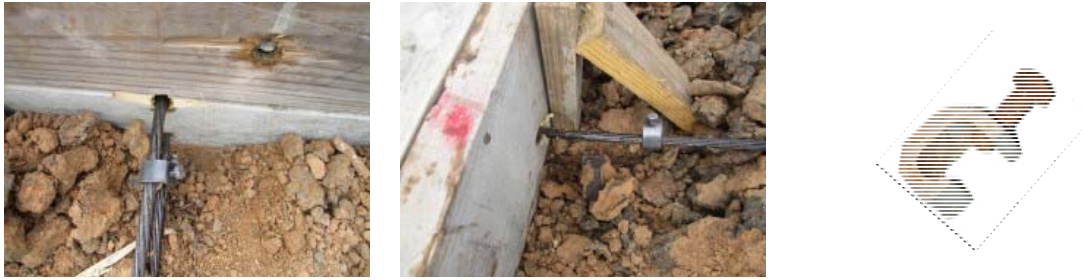
- Edge forms appeared to have been adequately braced with wood braces and backfill to prevent movement during concrete placement.
- Tendons were placed per construction drawings
 - 24 tendons, side-to-side, including 4 in the back patio
 - 19 tendons, front-to-back
 - ## tendons, total
- Dead-end and Stressing-end anchors appeared well set and secured against the edge forms.
- **Cat-heads were not snug against the form. This should be repaired before placement of the concrete.**

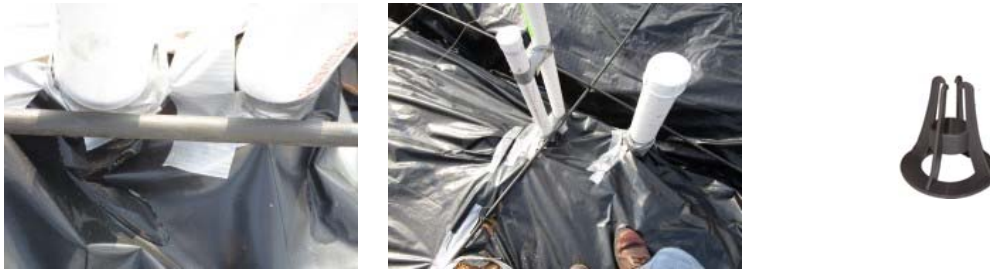
- No more than 1 inch of the encapsulated tendons was exposed at the stressing-end and no more than 12 inches of tendons were exposed at the dead-end.
- At least 16 inches of strand extended past the edge form.
- **Chairs had not been placed between reinforcing tendons and plastic drain pipes.** This may cause damage to the pipe during and/or following tensioning of the tendons. **This should be repaired before placement of the concrete.**

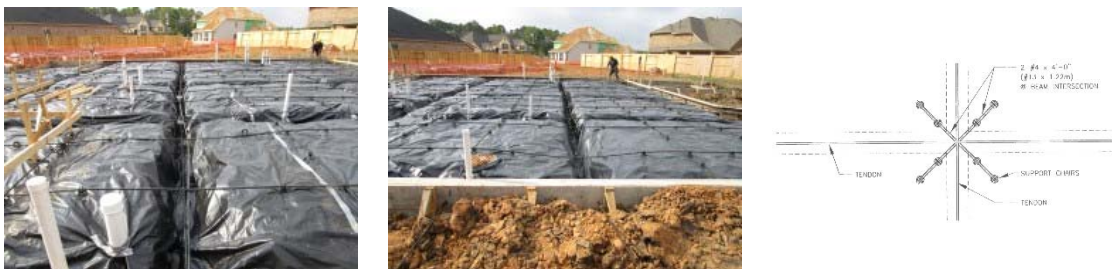
- **The plastic drain pipes had not been sleeved, wrapped or greased where they are to be in contact with the concrete.** Failure to do so will allow the concrete to bond to the plastic and cause them to become damaged over time. **This should be repaired before placement of the concrete.**
- There was no support of tendons over ribbed intersections. At interior beam intersections, slab tendons that are positioned directly over both beams can be supported by reinforcing bars that cross the beam intersection at diagonals. (PTI®) *The construction drawings did not call for reinforcement or support.*

Information: I met the project manager, Adan, on site during the inspection and identified the deficiencies noted above. By the end of this inspection, workmen had begun greasing the drain pipes and Adan said that he had called for the additional work to be done.
