Property Inspection Report

OPEN FRAME

Sammy Slumber
4830 Franklin Way Court
Iowa Colony, TX 77583
Meridiana

Inspection Date: 3/8/2020

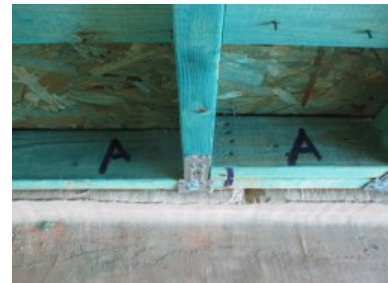
Less than 1" bearing on the left-hand plate and all nails were in the splice. Recommend anchors where marked "A".

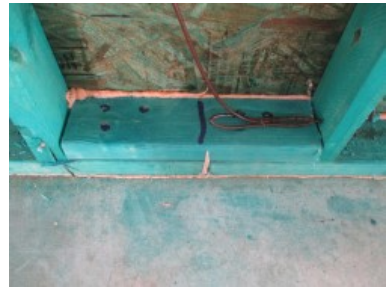
Not enough nails were used on either side of the splice. Recommend additional nails be placed.

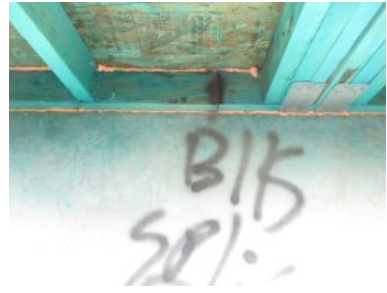
Marked by builder to be blocked across the splice but there will not be enough bearing for effective blocking. Recommend anchor be added

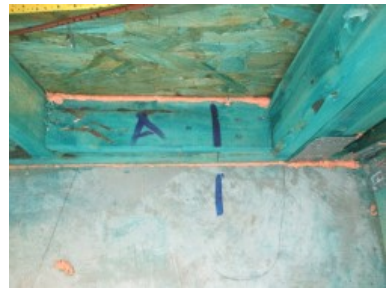
Not marked by builder. There will not be enough bearing for effective blocking. Recommend anchor be added

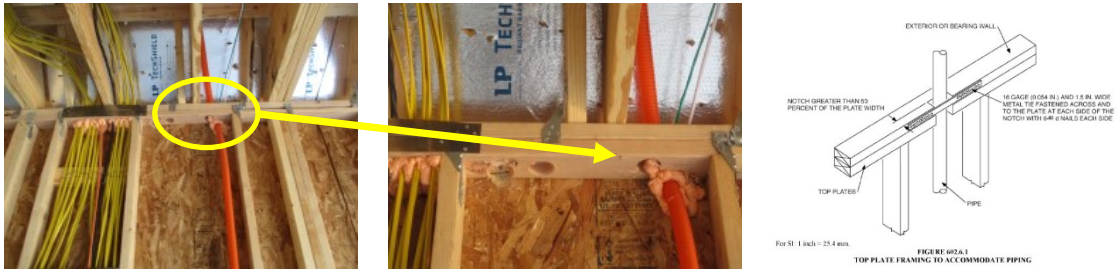
Top plates had been bored, or notched, more than 50% at electric non-metallic tubing (ENT), did not have proper strapping across the bored hole. "When piping or ductwork is placed in or partly in an exterior wall or interior load-bearing wall, necessitating cutting, drilling or notching of the top plate by more than 50 percent of its width, a galvanized metal tie not less than 0.054 inch thick (1.37 mm) (16 ga) and 1 1/2 inches (38 mm) wide shall be fastened across and to the plate at each

side of the opening with not less than eight 10d (0.148 inch diameter) having a minimum length of 1 1/2 inches (38 mm) at each side or equivalent. The metal tie must extend a minimum of 6 inches past the opening. See Figure R602.6.1." Note that there were partially bored holes to the left. The licensed design professional should determine whether those should also be strapped.

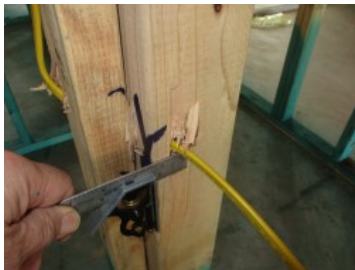
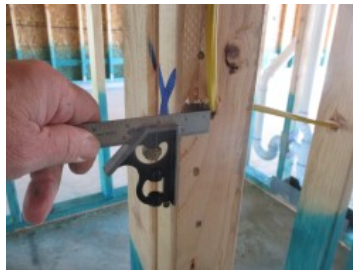
Bored holes did not all have nail plates installed to protect electrical cables. Non-metallic cables run through bored holes in framing members should not be closer than 1 1/4" from the edge of the framing member or should be protected with a minimum 0.0625-inch steel plate or sleeve, a listed steel plate or other physical protection. *Recommend nail plates be installed where marked.*

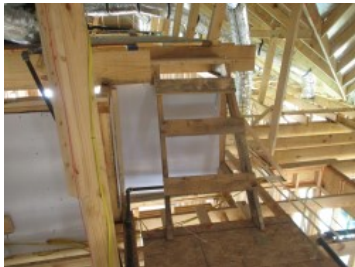
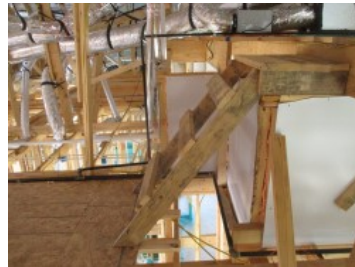
Access between levels of the attic space, up to the HVAC equipment was not safe. Filters required to be maintained by the homeowner were in the upper level space. "Appliances shall be accessible for inspection, service, repair and replacement without removing permanent construction, other appliances, or any other piping or ducts not connected to the appliance being inspected, serviced, repaired or replaced." Recommend safe access be installed including proper steps and railings (48" high change in level). [2015 IRC §M1305.1](#)
