# Property Inspection Report

**Billy Buyer  
1030 Montour Lane.  
Houston, TX 77059  
Clear Lake City  
Key Map 618D**

**Saturday, June 27, 2020**

**Concerning:** 1030 Montour Lane., Houston, TX 77059  
(Address or Other Identification of Inspected Property)

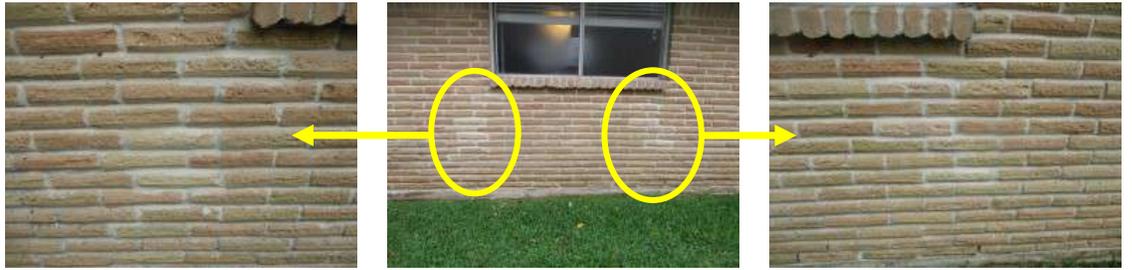
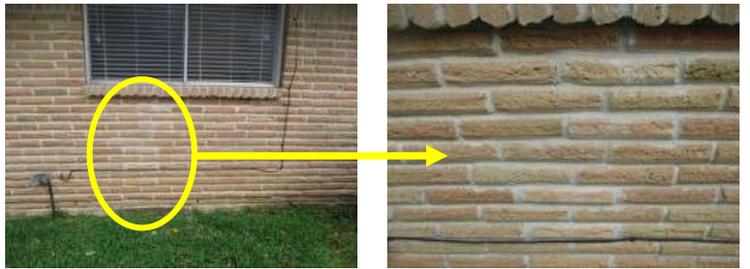
- repairs to mortared joints in the masonry veneer

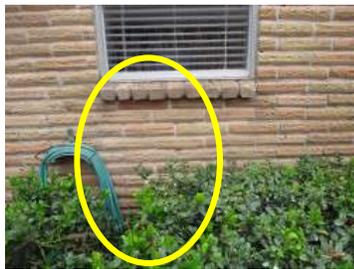
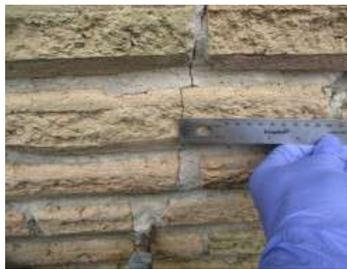
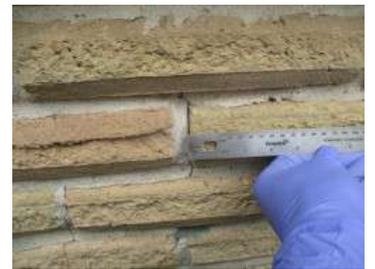
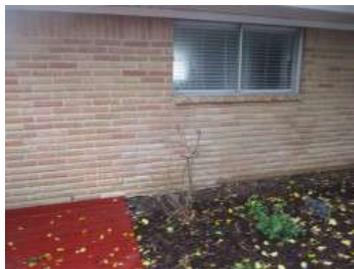
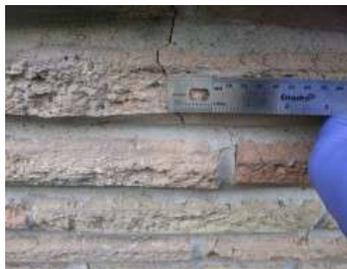
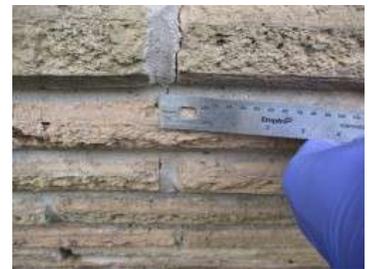
- cracks in masonry veneer

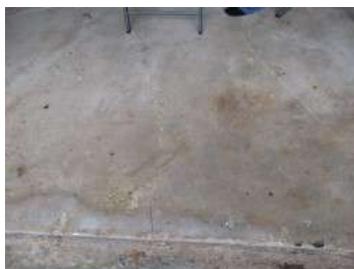
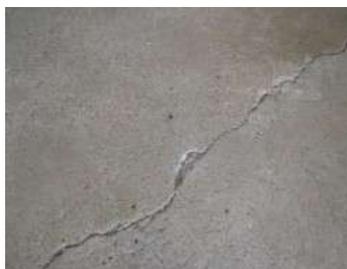
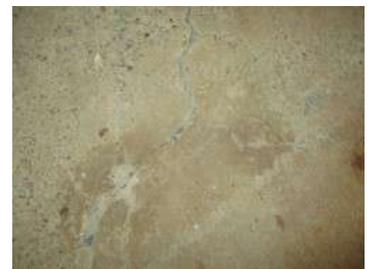
- cracks in concrete floor of garage

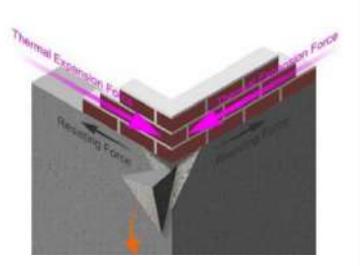
*Maintenance:* Spalling found within 12" of the foundation's corners may occur because of bonds between the brick and brick ledge and differential thermal movement. Spalling was noted at self-evident corners. This damage did not appear structurally significant and was not in need of repair at the time of this inspection.

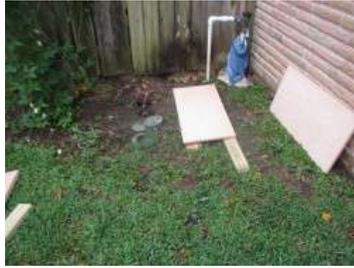
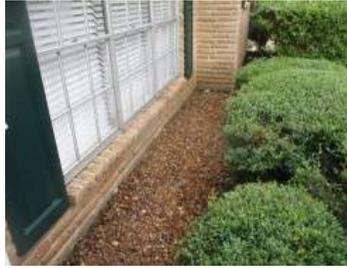
Representative

**This lot did not appear to have the proper slope for drainage at all points along the foundation grade beam; this may lead to foundation distress.** Lots should be graded to drain surface water away from the foundation walls. The grade should fall a minimum of 6" within the first 10'. Note that swales may have to be periodically re-cut to address the accumulation of yard clippings, mulch, leaves and other organic materials.

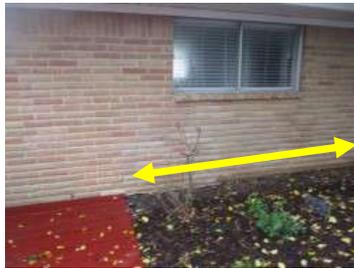
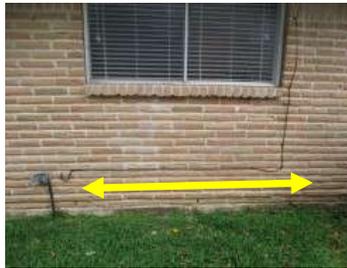
Representative

The soil levels were high against isolated areas of the foundation grade beam. When soil levels and vegetation are high against the face of the foundation it promotes water penetration, wood rot and insect infestation. Brick veneer wall cladding should have about 4" of clearance between the soil and the first course of bricks, and other materials should have 6" of clearance between other materials and the soil.

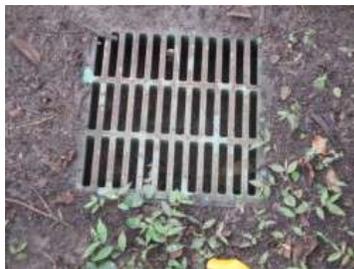
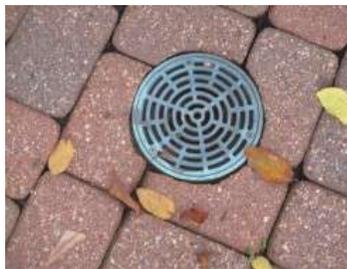
**Maintenance:** We noted the presence of underground drain lines. These lines, however, could not be tested in any manner consistent with significant rainfall or flooding and should not be considered to have been inspected. Note that underground drains are specifically excluded from this inspection by the Texas Real Estate Commission's Standards of Practice. The drain covers must be kept clean of vegetation, leaves and detritus to minimize the risk of obstructing the drain lines.

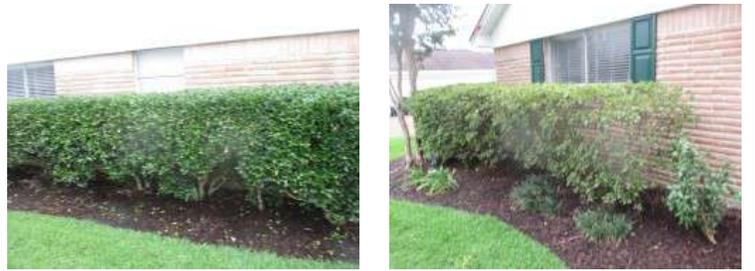
Representative

*Maintenance:* Shrubs planted too close to the foundation will hide the slab from view as they mature, creating conditions conducive to infestation by Wood Destroying Insects (WDI). Shrubs should not be planted closer to the slab than half of the mature width of the shrub.

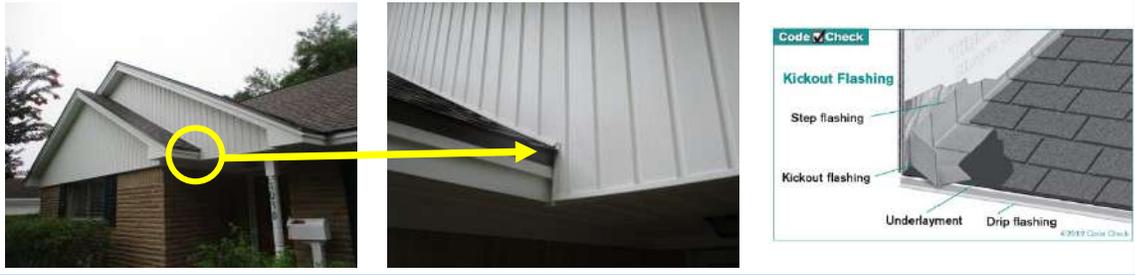
**No kickout flashing was observed at the front elevation.** This flashing is designed to divert run-off away from the wall to minimize the risk of moisture intrusion into the wall or roof structure. I could not evaluate termination of the flashing concealed behind the vinyl. It rained heavily in the past 72 hours and there was no immediate evidence of water intrusion. I cannot warrant that it will not cause damage, concealed or otherwise, in the future.

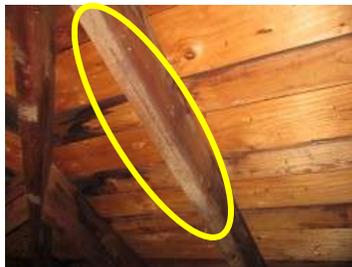
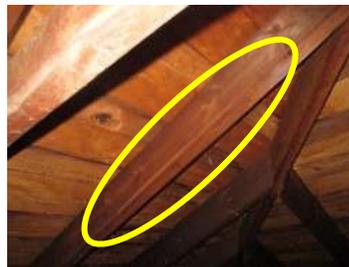
*Information:* Isolated rafters were cracked as observed from the top of the garage's pull-down stairway. These did not appear to be structurally significant cracks; recommend monitoring these for movement and separation.

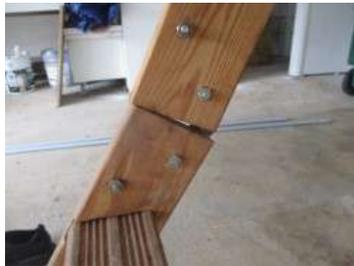
The stairway rails were not flush at the hinged sections. This may lead to personal injury should the rails split or crack while in use. The stair should be trimmed-to-height for personal safety.

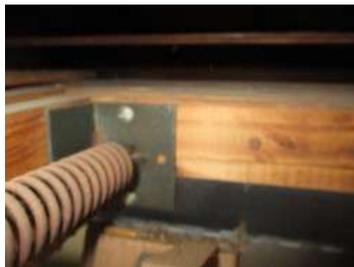
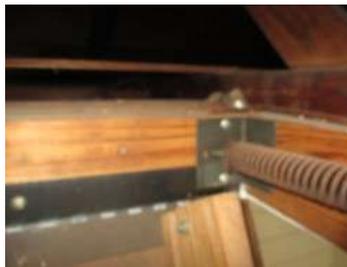
There were no fasteners within the stairway's corner brackets. Manufacturers typically require that attic stairways be installed with 16d nails through the corner brackets where the ballast springs are secured.

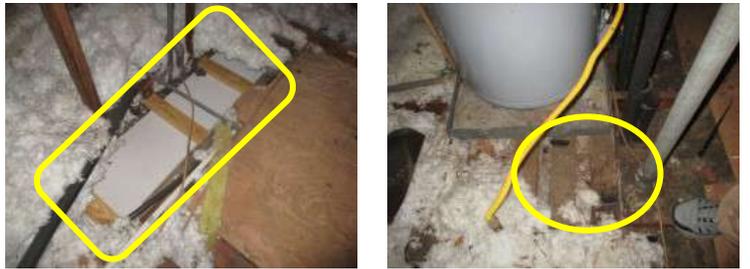
Insulation was missing in isolated areas, proximate to the Water Heater and HVAC equipment. These are common sources of water, and both pieces of equipment had been replaced.

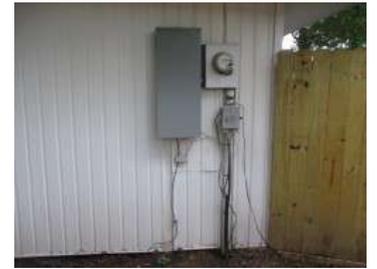
*Information:* There was no flashing installed or sealant applied above the electric service panel. Such flashing is intended to prevent moisture from passing through the masonry veneer behind the service disconnect. We recommend applying an exterior grade, permanently flexible caulk to seal the top and sides, but not the bottom, to minimize the risk of moisture penetration through the wall cover.

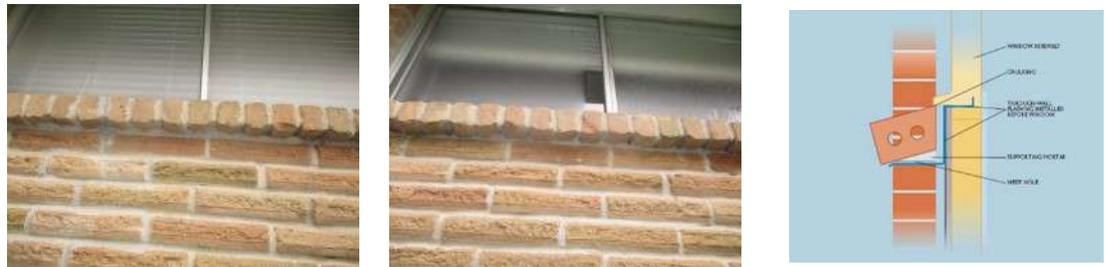
*Information:* No flashing or weep holes were observed beneath the brick rowlock-type sills beneath the windows set into masonry walls. While technically incorrect, this method used here is the most common method of installing the rowlock. No recommendation.

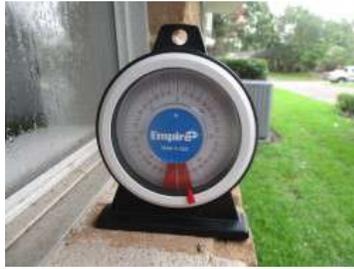
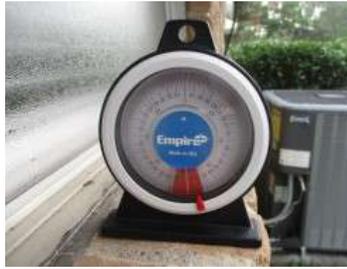
*Information:* The brick rowlock-type sills had a slope less than 15° from horizontal. Brick Industry America (BIA) recommends a minimum slope of 15 degrees (Technical Note 36, "Brick Masonry Details: Sills and Soffits") intended to prevent water from standing on the sill. The rowlock did slope away from the wall and there was no visible evidence of water penetration. No recommendation.

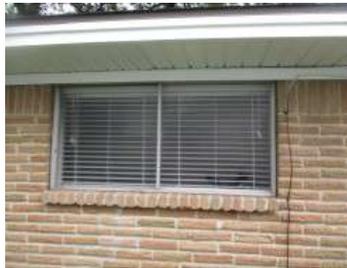
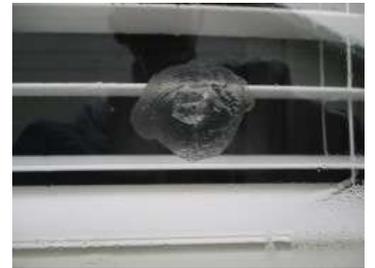
Window in the 3<sup>rd</sup> guest bedroom was broken; there was what appeared to be a rock-chip in the front-half of the sliding window.

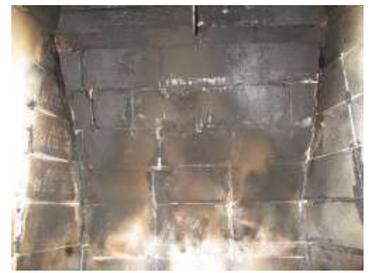
**Brick in the back of the firebox were loose.** Recommend a complete fireplace inspection by a qualified "Fireplace Inspector" before operating this fireplace with either gas or solid fuel.

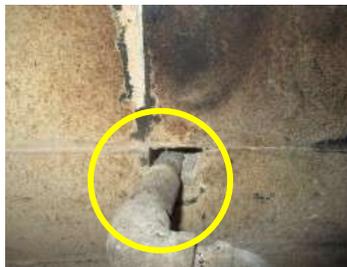
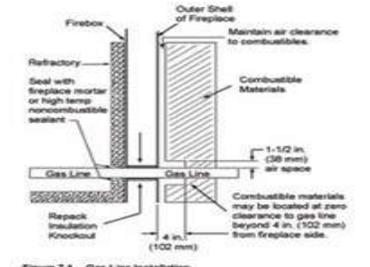
**The annular space between the gas line and refractory panel was not sealed.** The annular space be sealed with insulation, high-temp caulk or medium duty refractory mortar to prevent heated gases from entering the wood framed wall. We recommend sealing this area for fire and personal safety.

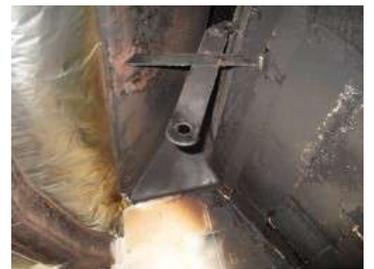
**Safety:** The fireplace damper control arm could not be reached from outside the firebox. While this is acceptable by Code, it creates a potential safety hazard in the opinion of this inspector. Should a fire be started with the damper closed, there is no safe way to open the damper. Care should be exercised.

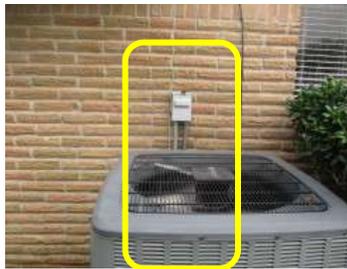
The A/C condenser's Service Disconnect was installed without proper clearance (i.e. 36" in front and 30" side-to-side). Access to the Disconnect should be free of obstruction, including the condenser itself. Note that this may apply to one or more condensers and it's disconnect.

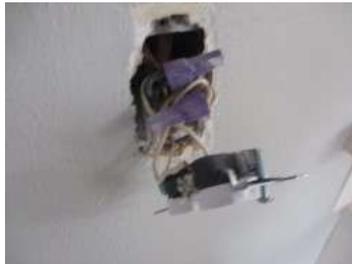
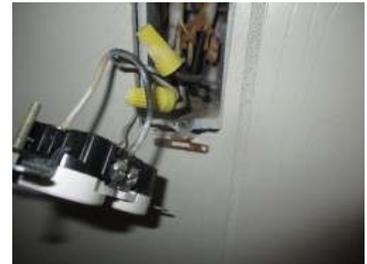
While there was no evidence of overheating or heat-based damage, recommend further evaluation of switches, receptacles, and other outlets for proper termination of aluminum conductors.

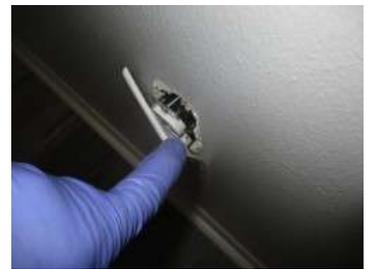
One receptacle was not fully secured in the inboard wall of the formal living room.

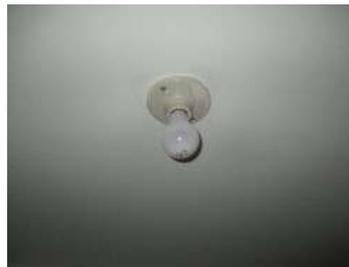
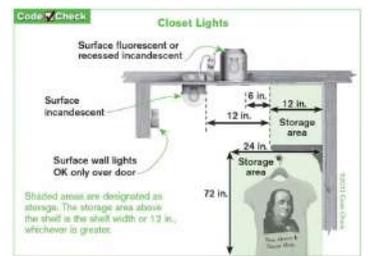
One, or more, incandescent lamps with open lamp holders were installed in clothes closets. Luminaries in clothes closets should be limited to surface mounted or recessed incandescent luminaries with completely enclosed lamps, and surface mounted or recessed florescent luminaries. This/these fixtures should be replaced with proper covered fixtures to reduce fire hazards created by the heat of the bare bulbs in possible close proximity to combustibles stored in the closets.

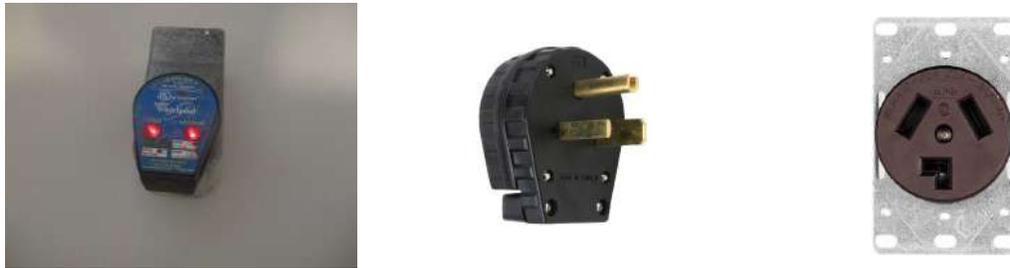
*Information:* The electric outlet/receptacle at the clothes dryer connection was a 3-prong outlet. Today's Code and appliances require that this be a 4-prong outlet for safety. While there was no apparent need to upgrade this to current Code it is necessary to know which plug configuration will be necessary for an electric dryer.

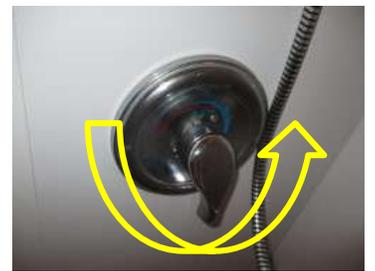
I could not get hot water at the master shower; the valve did not appear to function correctly. Water temperature should vary between Cold and Hot as the handle was moved counterclockwise. When I operated the handle in this manner, water temperature did not get hot, and at the end of its rotation, water was Off. Recommend repair or replacement.

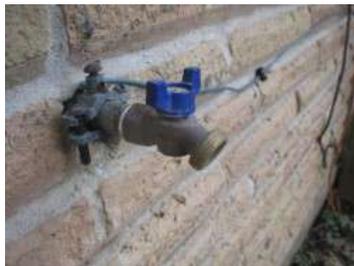
Vacuum breakers were missing from one or more hose bibs. Sill cocks, hose bibs, wall hydrants and other openings with a hose connection shall be protected by an atmospheric-type or pressure-type vacuum breaker or a permanently attached hose connection vacuum breaker for protection of the potable water supply.

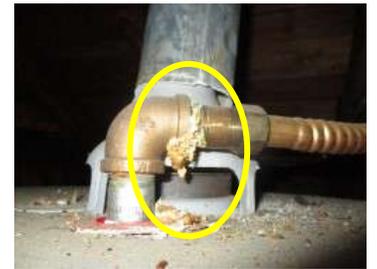
Mineral deposits accumulating on the threaded coupling reflected a slow leak. There do not appear to be dielectric couplings installed between dissimilar metals at the water heater's supply lines. Joints between copper, or copper alloy tubing, and galvanized steel pipe should be made with a brass fitting or dielectric fitting to prevent such galvanic reaction. Damaged lines and couplings should be repaired or replaced.

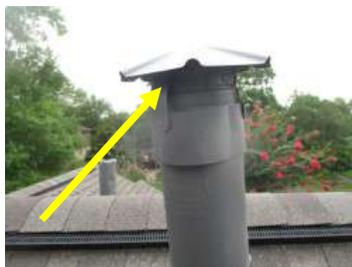
The cap had been pushed down to the flue and there was minimal, if any, opening to allow drafting of the combustion exhaust. While I lifted the cap to its proper position, recommend fastening it so that it does not drop back down.
