Property Inspection Report

Thursday, January 22, 2015

PROPERTY INSPECTION REPORT

Clay M. Collins, TREC # 7147

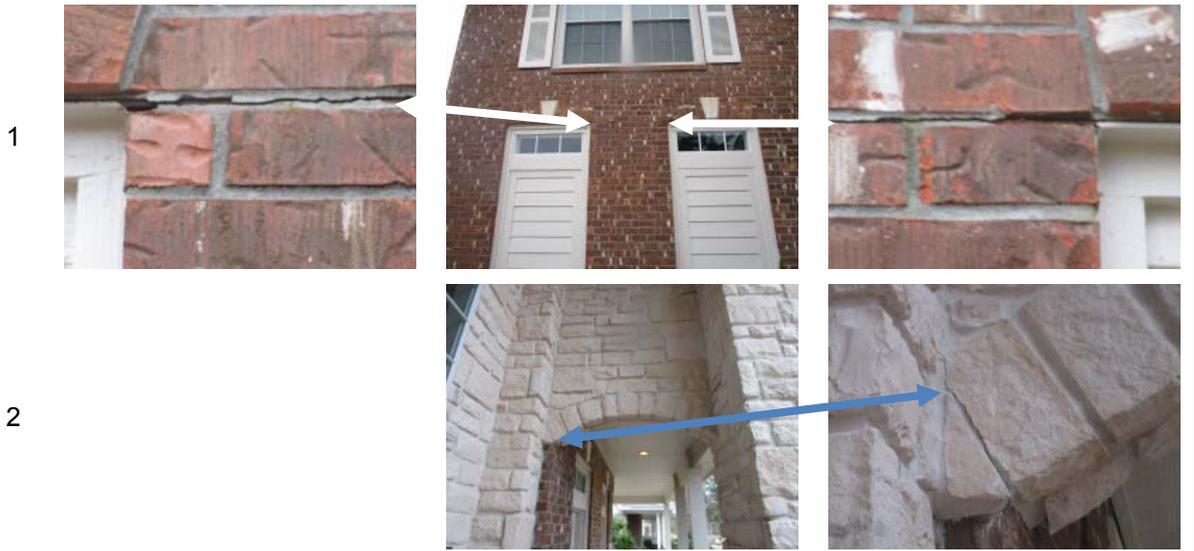
1. cracks in masonry veneer at lintel(s) between the two left-most front windows (See [I. Structural Systems E. Walls](#))
2. small crack in mortar above north/south arch at front door (See [I. Structural Systems E. Walls](#))
3. cracks in angled ceiling cover of 2nd floor, left-most bedroom and game room (See [I. Structural Systems F. Ceilings and Floors](#))
4. 3 windows did not latch without the use of force (breakfast room, left-most bedroom, back-right bedroom (See [I. Structural Systems H. Windows](#)))
5. drywall crack(s) on ceiling at attic pull-down stairway

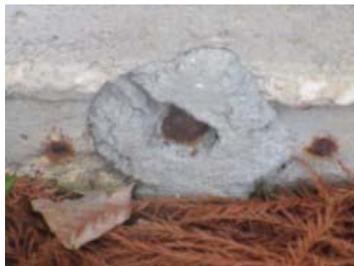
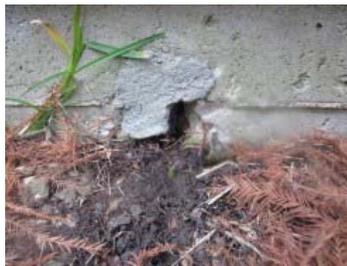
There was exposed reinforcing steel and/or tendons in the grade beam. This foundation was strengthened by post tensioned cables. The Post-Tensioning Institute (PTI) recommends that tendon ends be covered with at least 1" of grout. These should be sealed to prevent corrosion and potential failure of the cable. Do *not* use bagged cement or any product containing calcium chloride or other material deleterious to pre-stressing steel. See the illustration of the tendon "anchor" and "live" ends.

The Post Tensioning Institute (PTI) notes a requirement for a brass plate or stamp within the concrete floor of the garage space or metal tag on the water line noting: **Post Tension Slab: Do not cut or core.** Note that this requirement is for protection against repairs which may damage the cables and create additional damage to the foundation. These marking were not observed.

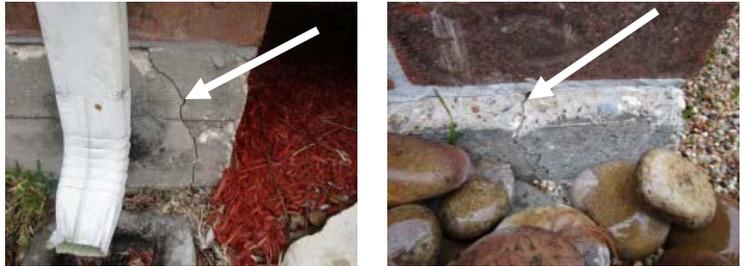
Maintenance: Spalling found within 12" of the foundation's corners may occur because of bonds between the brick and brick ledge and differential thermal movement. Spalling was noted at self-evident corners. This damage did not appear structurally significant and was not in need of repair at the time of this inspection.

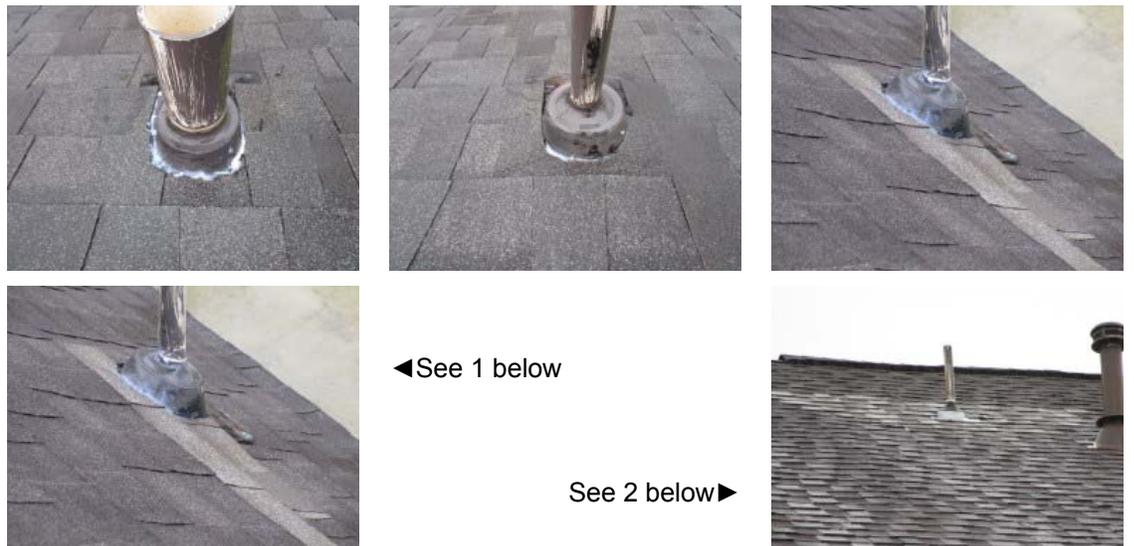
Information: There was evidence of previous repair to the roof cover including replacement of shingles and caulking (non-typical) of drain waste vent flashing.

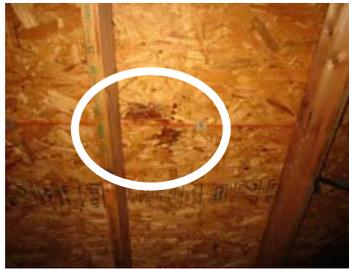
2

- In the attic space above the 2nd floor HVAC equipment proximate to a repair noted above
- At the drain waste vent at the top of the pull-down attic stairway

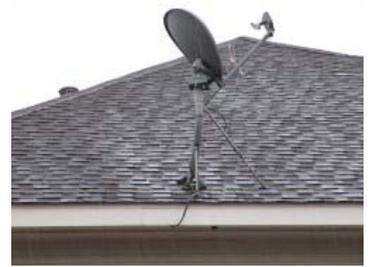
Maintenance: There were one or more dish-type antennas, or antenna mounting brackets installed on the roof. Items mounted to the roof such as satellites, antennas, basketball backboards, etc., may allow water penetration. As these items move (wind, adjustments to position, use, etc.), screws and bolts may enlarge mounting holes. While not in immediate need of repair, we recommend closely monitoring these areas and making repairs as soon as possible when necessary.

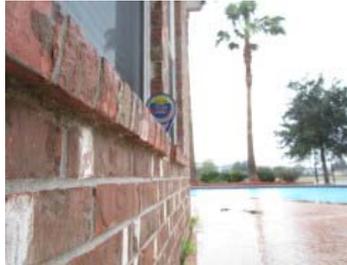
There was no flashing or weep holes observed beneath the masonry sill. While technically deficient, we make no recommendation for repair.

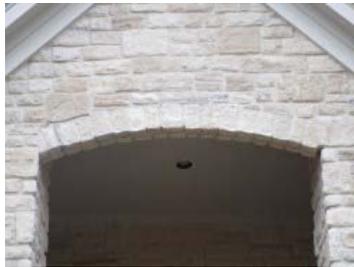
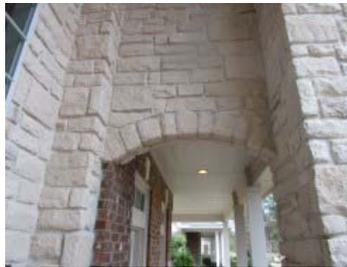
Masonry over openings shall be supported by steel lintels, reinforced concrete or masonry lintels or masonry arches, *designed to support load imposed*. We are not able to determine the design strength and limit our evaluation to visible evidence of movement or failure. *The arches appeared to be performing at the time of this inspection.*

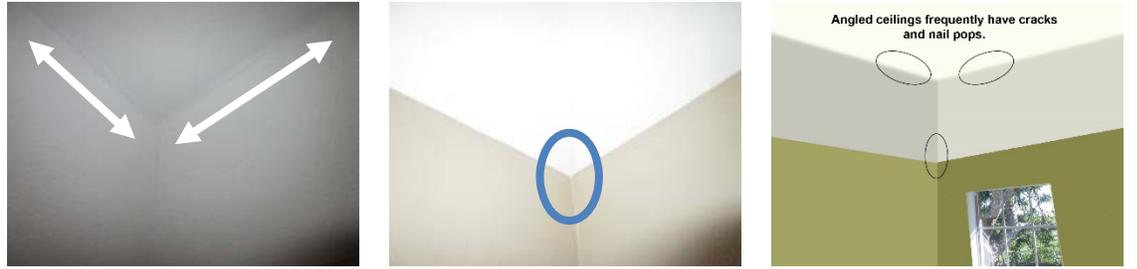
Information: There were cracks and/or nail pops within the angular ceiling joints of one or more rooms. Cracks in angular joints in ceiling covers are typically a result of the house's dehumidification process and thermal movement and not necessarily an indicator of settlement or structural movement requiring repair. Such cracks observed, in this inspector's opinion, were not deemed to be deficient or in immediate need of repair.

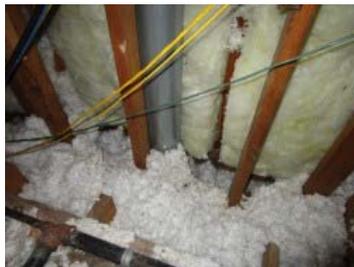
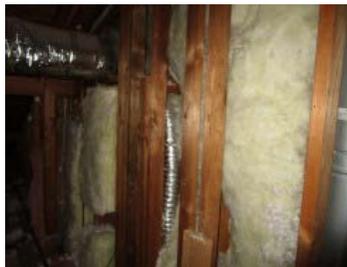
Insulation was in direct contact with the gas flue.

The combustion air vent was not properly installed. The exterior air intake for a fireplace shall not be located at an elevation higher than the firebox and shall be capable of supplying all combustion air from the exterior of the dwelling or from spaces within the dwelling ventilated with outside air such as non-mechanically ventilated crawl or attic spaces. Note that manufacturers may allow alternative design and methods and points of termination. The owner's manual was not available for evaluation.

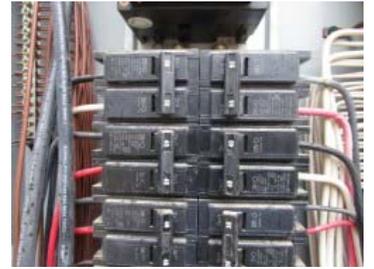
◀ Multiple neutrals on one lug

White as hot ▶

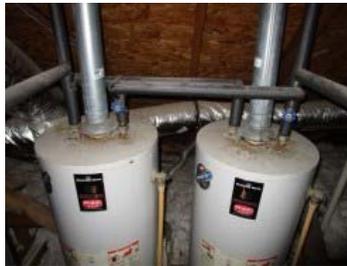
Metallic water pipes were not bonded across the Water Heater.

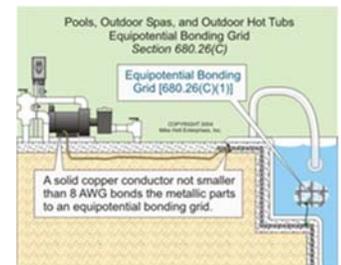
Bonding conductors were observed on each of the pool pumps, heating equipment and air blower, but we could not determine whether the conductor properly connected to the pool's bonding grid (buried system not visible). Metal parts of electrical equipment associated with pool, spa and hot tub water circulating systems, including pump motors, should be bonded with a minimum of solid 8 AWG conductor.

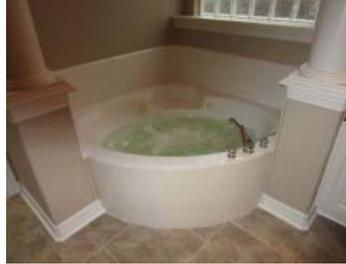
We could not determine whether the Hydro-massage Tub equipment (i.e. circulation pump) was properly bonded; there was no immediate access to the pump.

This should not be considered an all-inclusive or exhaustive list of deficiencies in the electrical system and many of these items may be technical deficiencies without real need for repair. A qualified, licensed electrical contractor should be selected to further evaluate these service panels, and the conditions noted in § II. *Electrical Systems B. Branch Circuits* below and make repairs and replacements as necessary.

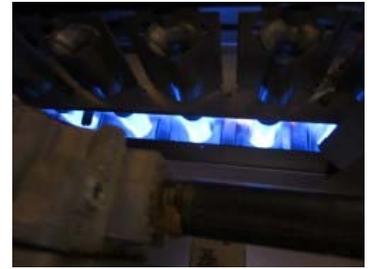
The heating cycle appeared to be performing as intended within acceptable limits. (only one photographed)

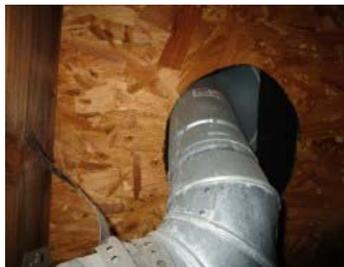
The first floor furnace's gas flue was in direct contact/near contact with the combustible roof deck. Type B Gas Vent requires a minimum of one-inch clearance to combustibles.

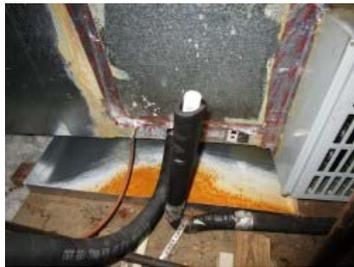
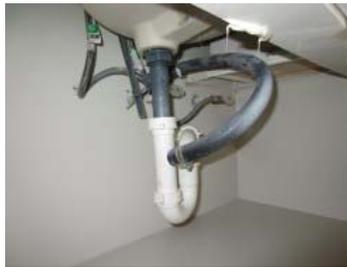
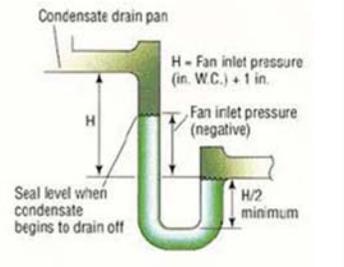
Both the international Plumbing Code (IPC) and the Uniform Plumbing Code (UPC) require that the condensate piping, as an indirect drain line, be trapped. Note that these drain lines discharged to the underside of a bathroom lavatory or lavatories which did incorporate traps. Only one of two pair pictured below.

Maintenance: This inspector recommends that the air conditioner's primary condensate drain lines be flushed of bacterial clogs by pouring a 1:9 mixture of household bleach and water through the line every month or so during cooling season. There was a vent in the drain line at the evaporator coil (located in the attic) for this purpose. Only one of two pair pictured below.

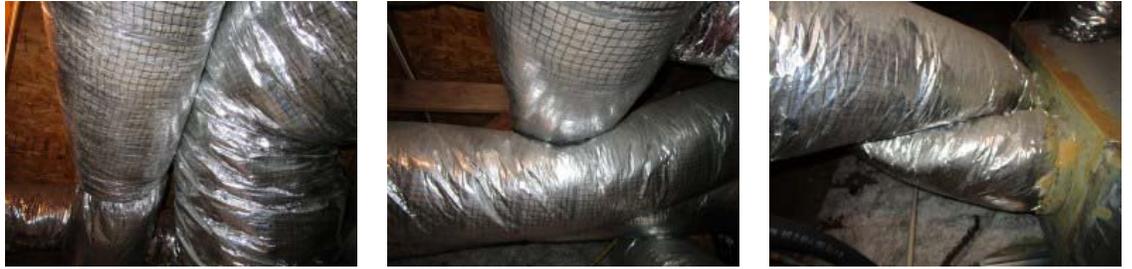
that the duct be separated by air space. Note that the photos below are representative and may not reflect all deficiencies.

Six or more supply registers were installed backwards and should be turned 180°. Supply register placement along an interior wall with supply throw toward the outside walls is the proper orientation in a cooling climate such as Texas. Manual T (Air Distribution Basics) from ACCA supports this air pattern. Air conditioning supply registers are intended to wash the outside walls; that is, to direct air against the outside walls and windows and to return that hot air to the system for removal of that heat.

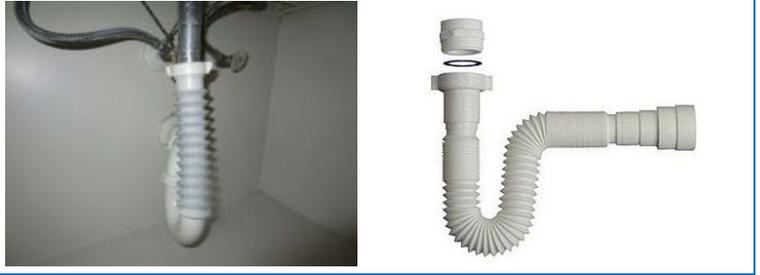
There was an unlisted drain line installed beneath the right hand master bathroom sink. Flexible drain lines are considered to be temporary repairs due to the propensity of the ridges to trap oils, hair, debris, etc. leading to blockage. We recommend that temporary drain lines be replaced.

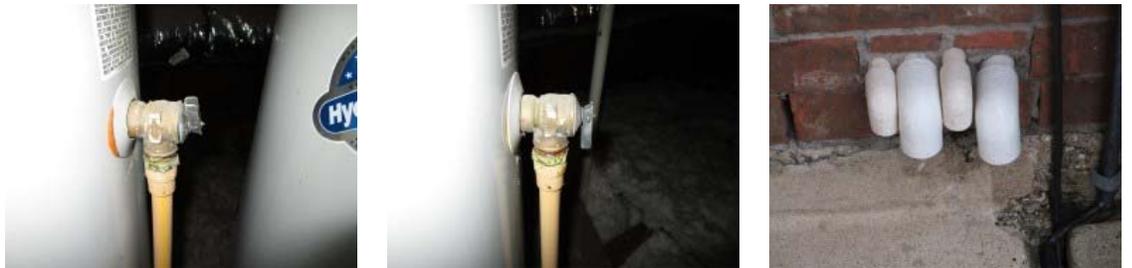
The temperature and pressure relief valve (T&P), or valves, were tested and appeared to be functional.

Safety: *Manufactures typically require* that temperature and pressure relief valves be tested at least annually, with more frequent testing preferred. Most require that these valves be removed and inspected by a qualified plumber every 3 years. If the valves were found to be worn or defective as the result of testing and/or inspection, they should be replaced. When a T&P valve is not tested regularly, the build-up of mineral deposits is extremely likely to prevent proper reseating of the valve and may allow water to leak. (Date Code: 0131E = 2001 – applied to both).

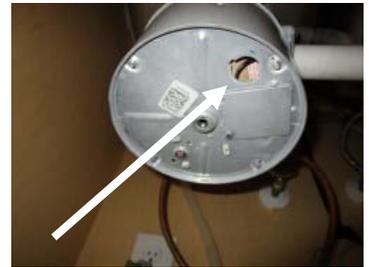
The disposer did not have a cord and plug installed and the appliance could not be operated.

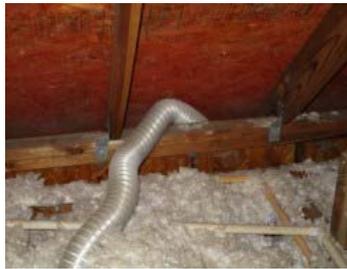
One or more bathroom exhaust fans did not terminate outside the building. We were not able to view the point of termination for *some* of the bathrooms' exhaust fans to allow a full inspection and evaluation, but there were no roof or wall jacks observed which could have served as a point of termination. These vents, therefore, were also presumed to terminate within the attic or at the soffit. The air removed by every mechanical exhaust system should be discharged to the outdoors. Air should not be exhausted into an *attic, soffit, ridge vent* or *crawl space*.

One louver was missing from one vent cover on the left side.

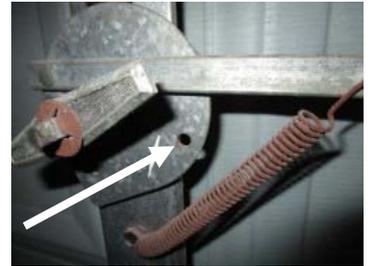
The door lock, or locks, was not disabled on doors with operators present. Locks, on garage doors controlled by a garage door opener, should be disabled or removed. Attempting to open a locked door may result in damage to the door, or the unit may be pulled from its mounting causing property damage or personal injury.

A bolt through the hole indicated will effectively disable the lock.

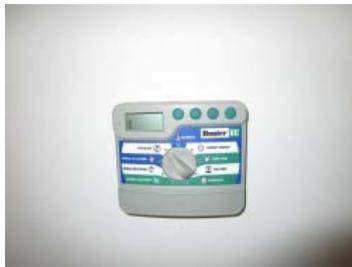
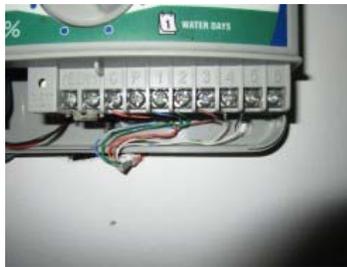
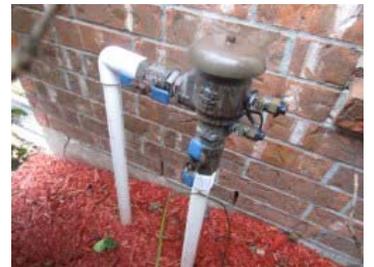
The appliance did not operate. While there were bars on the left side of the display, no other characters were displayed in any of the controller's switch positions. The low voltage control wires appeared to pass through the drywall and into the attic space to a ceiling receptacle intended for an overhead door operator.

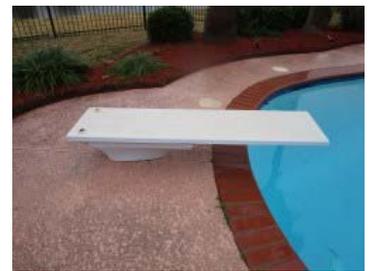
We recommend removal of the diving board for personal safety and to protect against liability and claims.

The pool barrier(s) were not proper for personal safety and protection against liability claims. There are specific requirements regarding locks and access to exterior areas providing direct access to swimming pools. Complete information on barrier and door requirements when there is a pool is located in the Addendum.

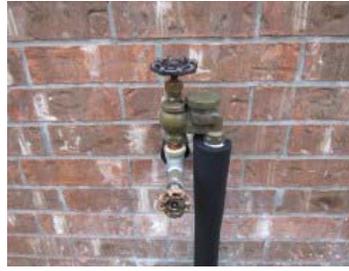
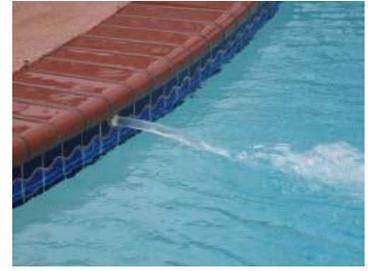
Information: The pool fill valve was located at the left, front corner. There was a backflow preventer observed.
