# Property Inspection Report

**Amos Benjamin Charles  
5411 Marble Acres Ct.  
Houston, TX 77059-1413  
Reserve at Clear Lake**

**October 01, 2017**

**Concerning:** 5115 Marble Acres Ct., Houston, TX 77059  
(Address or Other Identification of Inspected Property)

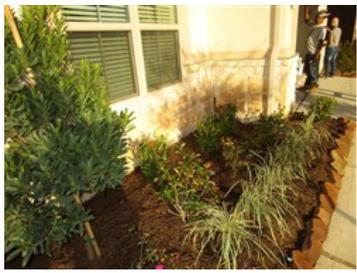
*Maintenance:* Grading and drainage conditions frequently contribute to the attraction of Wood Destroying Insects (WDI) the highest infestation of which within the United States is located here along the Gulf Coast. This inspector recommends a periodic inspection, preventative treatment or treatment for active infestations as necessary.

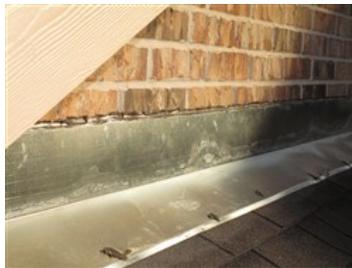
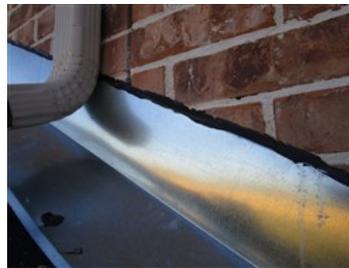
**Notice:** We could not positively determine that the counter flashing was set into reglets or tucks in the masonry veneer. The caulk seal at the top of the counter flashing should be considered temporary and will require periodic replacement.

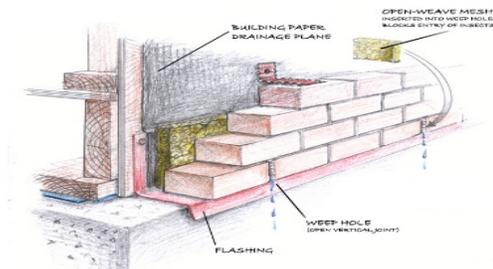
*Maintenance:* Weep holes should be located “in the outside wythe of masonry walls at a maximum spacing of 33 inches on center” and should not be less than 3/16” in diameter and should be located immediately above the flashing. The purpose of weep holes is to allow water which may penetrate behind the brick veneer to drain outside the structure. These should not be plugged or sealed, doing so may prevent moisture drain from behind the masonry and will not prevent insect infestation. Mulch, soil, etc. should not be allowed to cover these holes to minimize the risk of Wood Destroying Insects (WDI) infestation. [\[2009 IRC §R703.7.6](#)

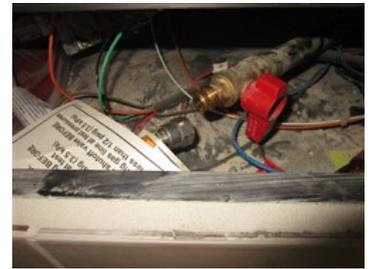
**Notice:** The gas supply had not been connected to the fireplace and the appliance could not be tested. The Builder should demonstrate its performance during the final walkthrough.

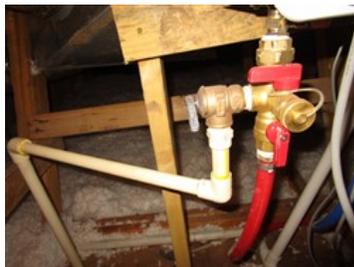
Normal position

The temperature and pressure relief valve (T&P), or valves, were tested and appeared to be functional.
