Property Inspection Report

PRE-POUR

Amos Benjamin Charles
5115 Marble Acres Ct.
Houston, TX 77059
Reserve at Clear Lake

July 01, 2017

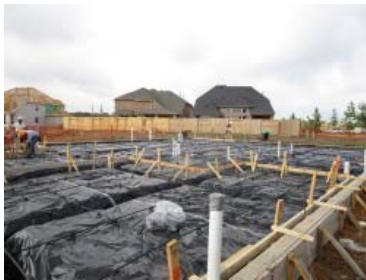
◀FL toward BR (A)

- General Foundation Note #15; "Refer to publication "Construction and Maintenance Procedures for Post-Tensioned Slab-On-Ground Construction" for additional guidance for the builder and the owner."
- Measurements against the construction drawings were made (A) along the diagonal from the front left to back right, and (B) from the front right to the back left.

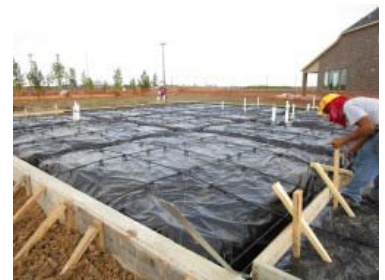
(B) FR toward BL▶

- The depth, width of the beams and thickness of the slab appeared adequate and generally met the values stipulated in Grade Beam Schedule.

Depth (24"): (A) 21, 26, 26, 26, 25
 (B) 27, 24, 24, 24, 25
