Property Inspection Report

OPEN FRAME

Sammy Slumber
4830 Franklin Way Court
Iowa Colony, TX 77583
Meridiana

Inspection Date: 3/8/2020

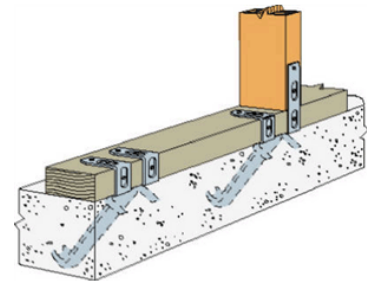
Simpson Strong-Tie page [MASA/MASAP](#)

Information: While, there were no anchor bolts installed in the sill plates of the exterior walls, we did observe Simpson Strong-Tie® Mudsill anchors that meet or exceed the anchorage requirements. *Refer to design specifications.*

- Testing shows that these mudsill anchors can be used in lieu of code-required anchor bolts and square washer in high seismic zones.
- Minimum MASA end distance is 4" and minimum center-to-center spacing is 8" for full load

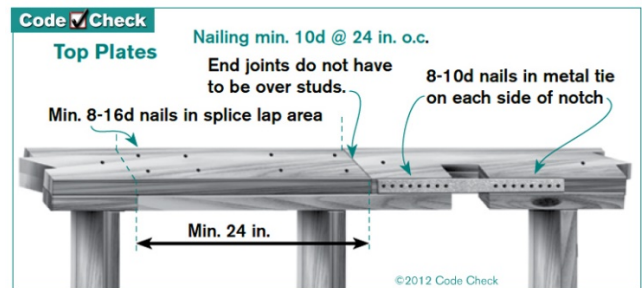
Illustration

Minimum 8-16d nails in splice lap area (4 each side)
