# Property Inspection Report

**Billy Buyer  
1030 Montour Lane.  
Houston, TX 77059  
Clear Lake City  
Key Map 618D**

**Saturday, June 27, 2020**

**Concerning:** 1030 Montour Lane., Houston, TX 77059  
(Address or Other Identification of Inspected Property)

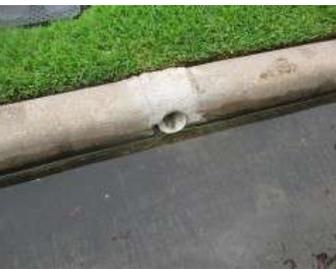
**Maintenance:** Gutters and downspouts were installed at some eaves of this structure. We recommend, however, that as a structural improvement, gutters be installed on all horizontal fascia and that the downspouts direct water at least 5' away from the structure. This will improve drainage and reduce erosion and ponding which adversely affect foundations, driveways and sidewalks.

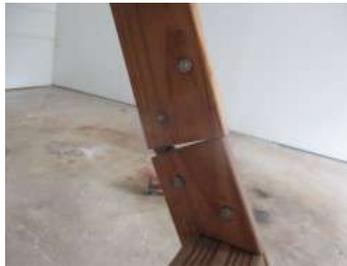
The stairway rails were not flush at the hinged sections. This may lead to personal injury should the rails split or crack while in use. The stair should be trimmed-to-height for personal safety.

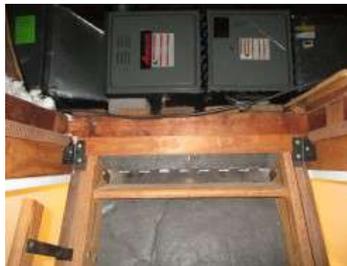
The stairway header was not fastened to the framing member at the attic opening.

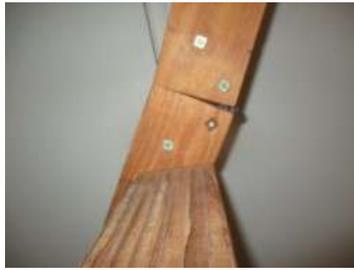
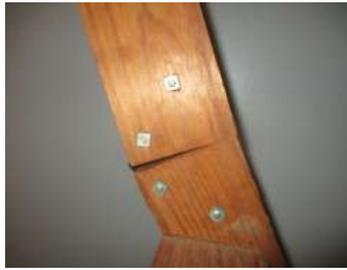
The stairway rails were not flush at the hinged sections. This may lead to personal injury should the rails split or crack while in use. The stair should be trimmed-to-height for personal safety.

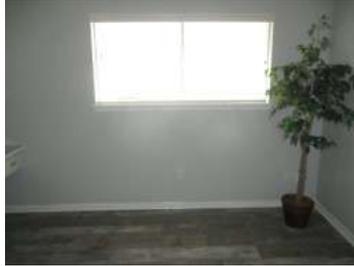
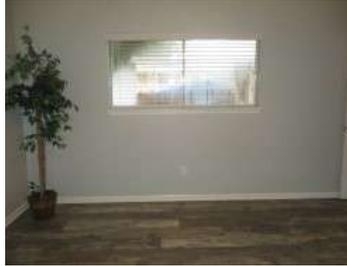
Window in the 3<sup>rd</sup> guest bedroom was broken; there was what appeared to be a rock-chip in the front-half of the sliding window.

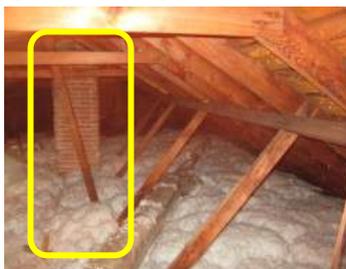
**Notice:** There was no safe access to the attic space at the fireplace chimney and we were not able to evaluate fire blocking. Fire blocking shall be provided to cut off all concealed draft opening to form effective barriers between stories and between the top story and the roof space and all spaces between chimneys and floors and ceilings through which they pass.

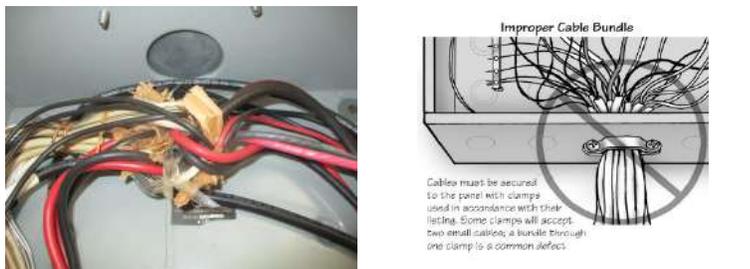
*Information:* Branch conductors filled more than 75% of a raceway and individual conductors were not secured to the panel cabinet. Such constriction of conductors may generate excessive heat and de-rate the amperage of the cables. Each cable is to be secured to the panel box. While not technically correct, this method of installation is used on virtually all exterior-mounted cabinets and many cabinets installed within stud cavities on inside walls.

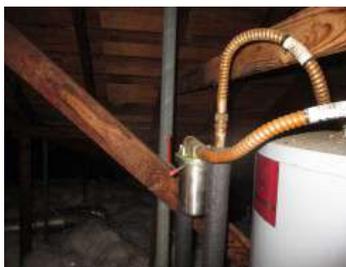
**Metallic gas pipes did not appear to be bonded, or there was no evidence of bonding, to the electrical grounding system.**

**Metallic water pipes were not bonded across the Water Heater.**

This should not be considered an all-inclusive or exhaustive list of deficiencies in the electrical system and many of these items may be technical deficiencies, but not material or in need for repair. A qualified, licensed electrical contractor should further evaluate these service panels, and the conditions noted in § II. Electrical Systems B. Branch Circuits below and make repairs and replacements as necessary.

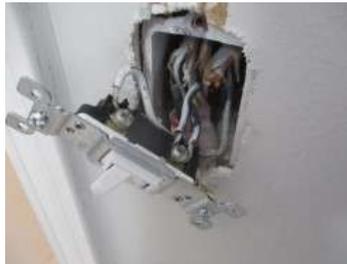
- Aluminum conductors at a receptacle had copper "pigtailed" to them with purple wire-nuts rated for use with aluminum wire.
- Aluminum conductors at a switch had not been pigtailed and the switch was CO/AL (copper/aluminum), not CO/ALR (copper/aluminum revised).
- 12 AWG aluminum conductors were reduced to 14 AWG aluminum using standard wire nuts not intended for aluminum wiring.

While there was no evidence of overheating or heat-based damage, recommend further evaluation of switches, receptacles, and other outlets for proper termination of aluminum conductors.

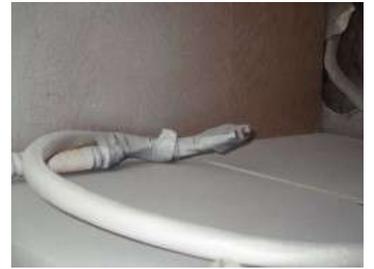
Conductor splices at the electric Cooktop were not made-up within a listed junction box, and the splice was taped preventing observation and evaluation of the method used to join the conductors. The size of the taped connection suggests that this was not a mechanically secured splice.

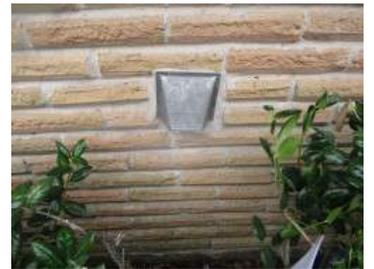
No adverse and material issues deficiencies were observed at the time of this inspection.
